# PITZ Experience with Gun5.1

Gun5 measurements and Status of L-Band conditioning facility

Mikhail Krasilnikov for the PITZ team  
XFEL MAC, 08.11.2023

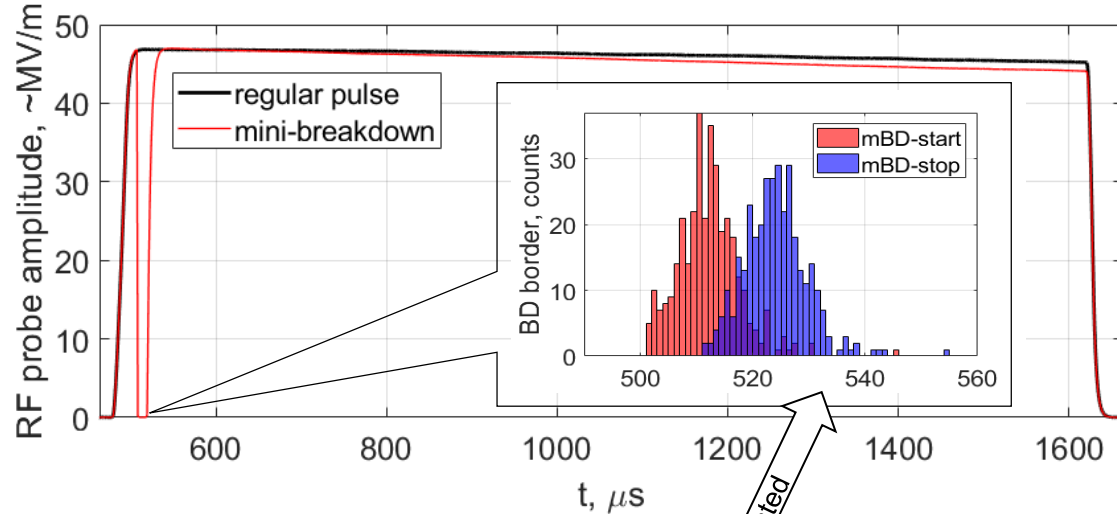
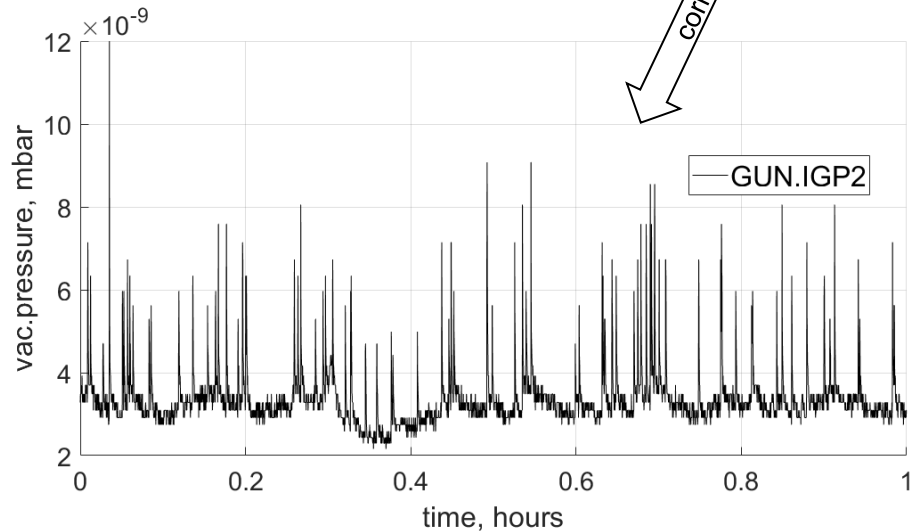
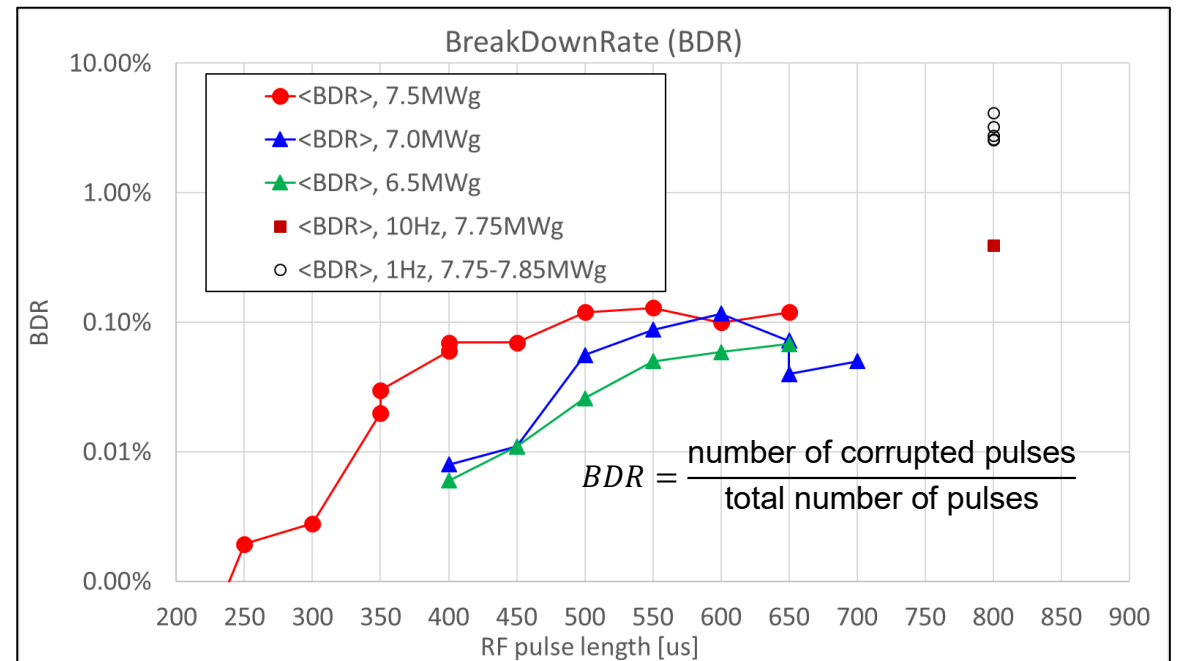
## Mini-breakdown (mBD) events

- Short ( $\sim 10\mu\text{s}$ ) interruption in RF pulse (cavity pickup and reflected power signals) + recovery within the same pulse (with a typical  $10..15\mu\text{s}$  cavity filling time)
- Majority of mBDs - in the first  $30\mu\text{s}$  of the pulse, also (seldom) at middle to end of pulse, very seldom – multiple drops
- Independent on fill/rise time ( $2..50\mu\text{s}$ ) of RF pulse ( $>300\mu\text{s}$ )
- Fast diode  $\rightarrow$  typical “switching time” of an interruption  $<100\text{ns}$
- Always accompanied by a vacuum mini-spike
- Also seen by IL sensors (VWV PMT + e-detector at the RF window, all under IL threshold)
- Source location is not clear (tests with permanent magnets  $\sim 0.4\text{T}$  around the coaxial coupler close to the gun cavity  $\rightarrow$  no dependence observed)

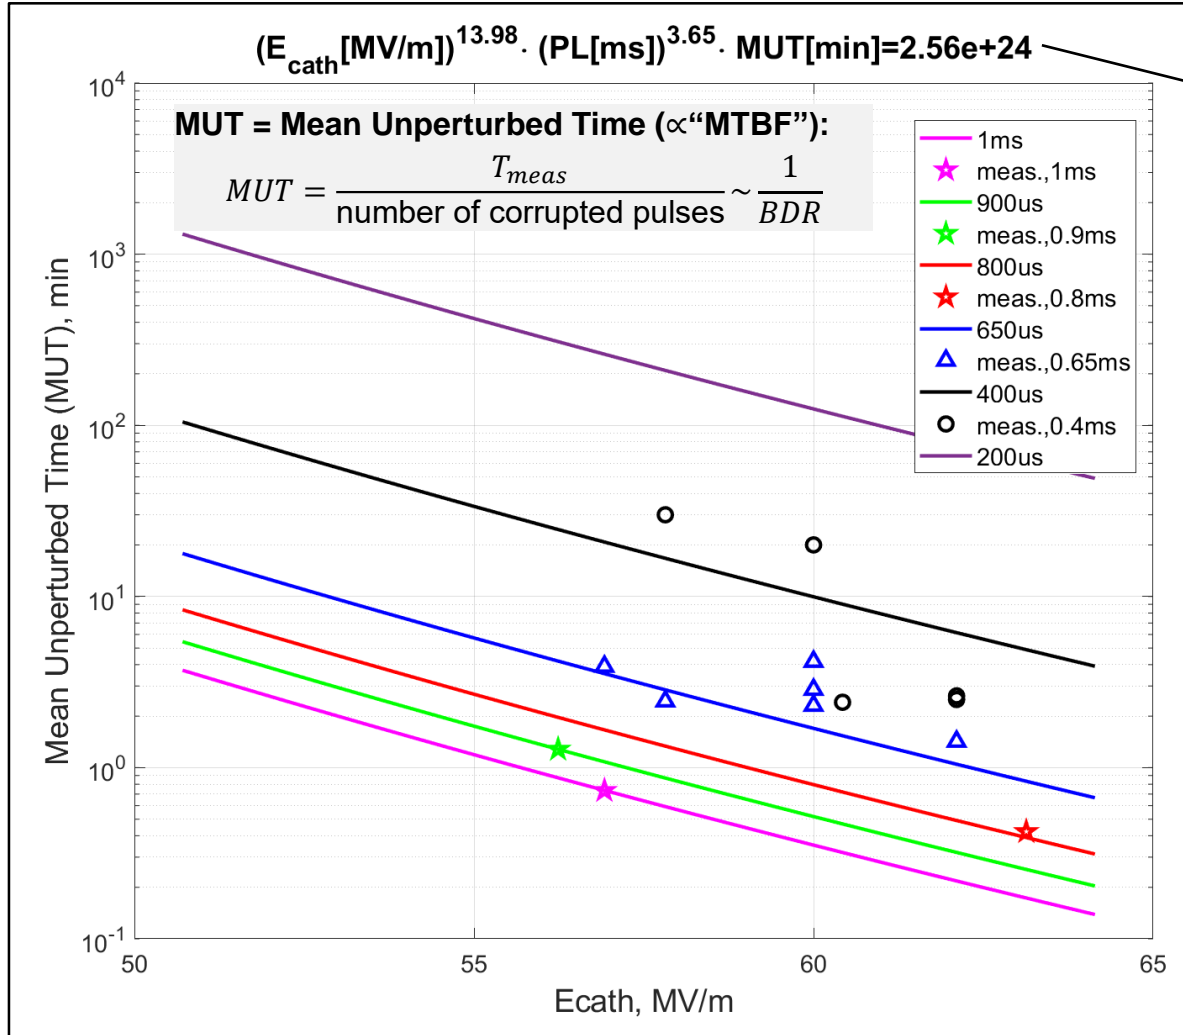
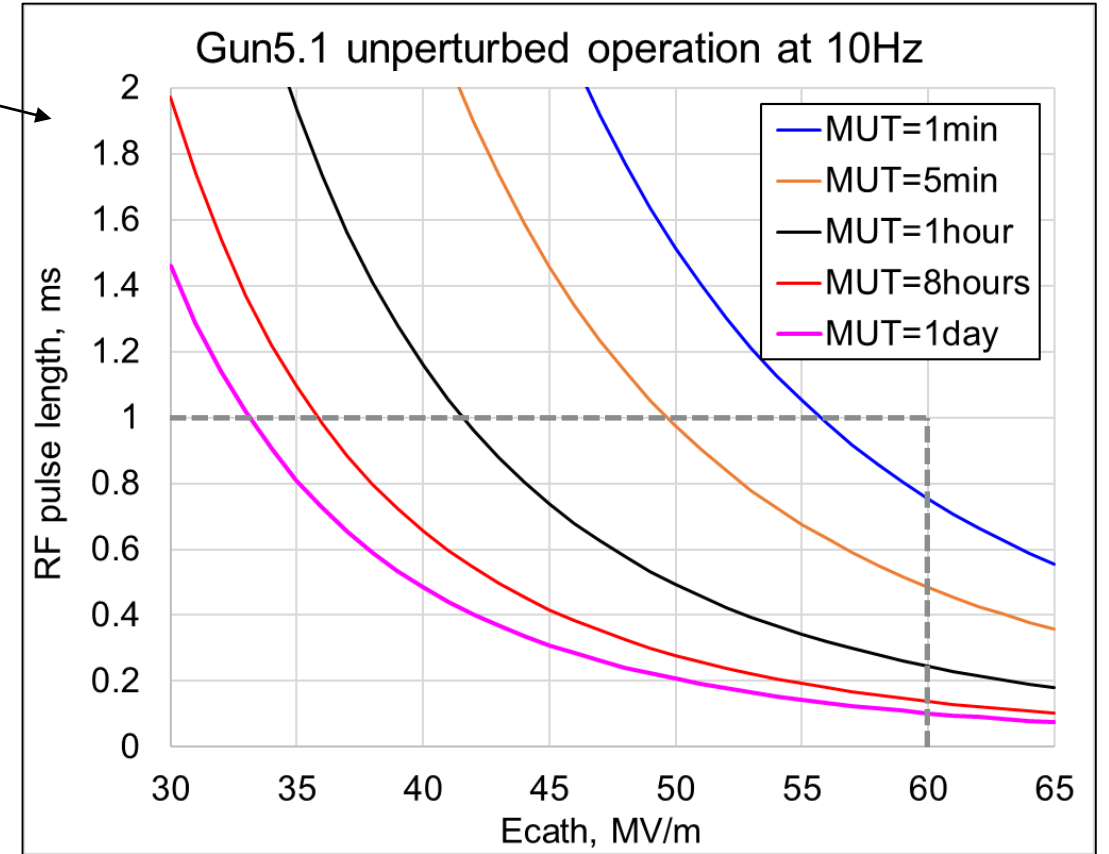
## Mini-breakdown (mBD) events systematic studies

$$\frac{E_0^{30} \cdot \tau^5}{BDR} = \text{const}, \quad \text{New local field quantity describing the high gradient limit of accelerating structures}$$

NB:  $E_{\text{cath}} \rightarrow$  beam momentum based gun power calibration

Mini-breakdown does not stop the operation, but with long RF pulses the gun RF feedback can lead to instability and even gun interlock (trip)!

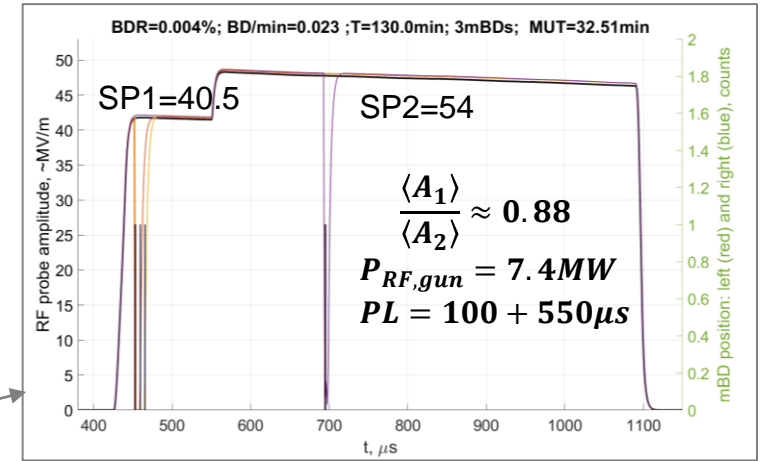
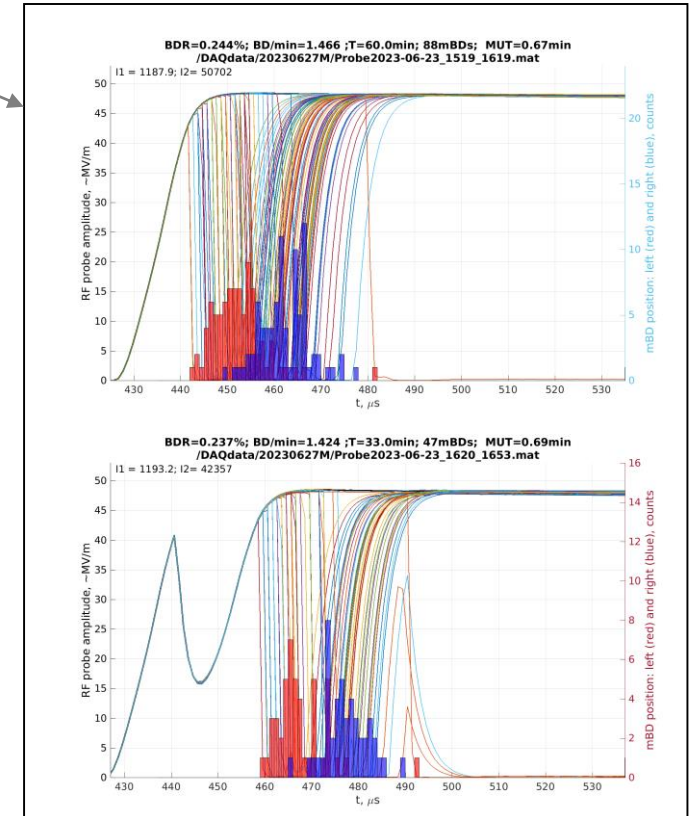
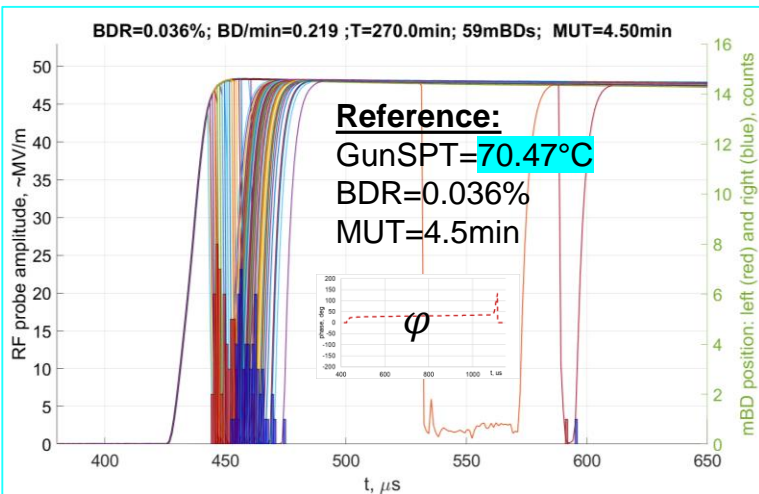
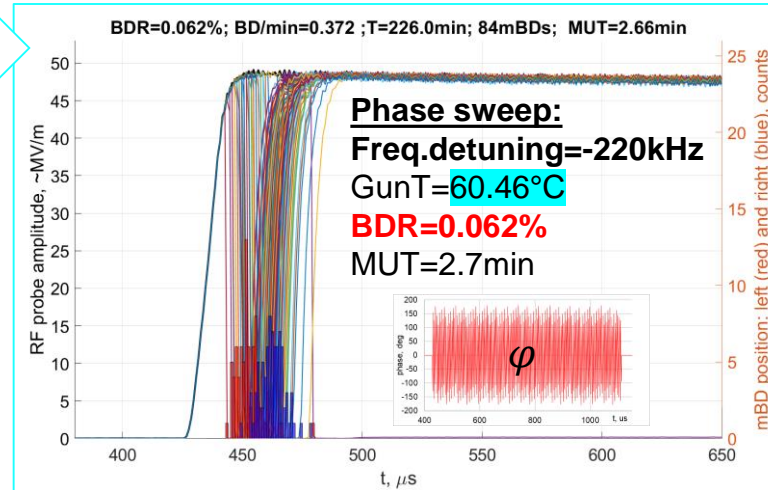
## Mini-breakdown rate (mBDR) : summary + some specific studies

- Depends on peak power, RF pulse length, repetition rate  
mBDR(1Hz) > mBDR(10Hz)
- Does not seem to be significantly improved by conditioning
- Slightly reduced using “multi-flattop” option → by lowering the 1<sup>st</sup> 100us pulse amplitude still in the first 30μs, but applied modulation in the beginning of the pulse -> mBD location shifted
- DC voltage (±25V) applied to the RF pickup → mBDR remains the same
- No dependence on gun resonance (gun temperature → reflection) observed
- increases with lower gun water temperature (cavity detuning by a phase sweep, e.g., -10°C → cavity detuning by ~-220kHz → x2 higher mBDR)

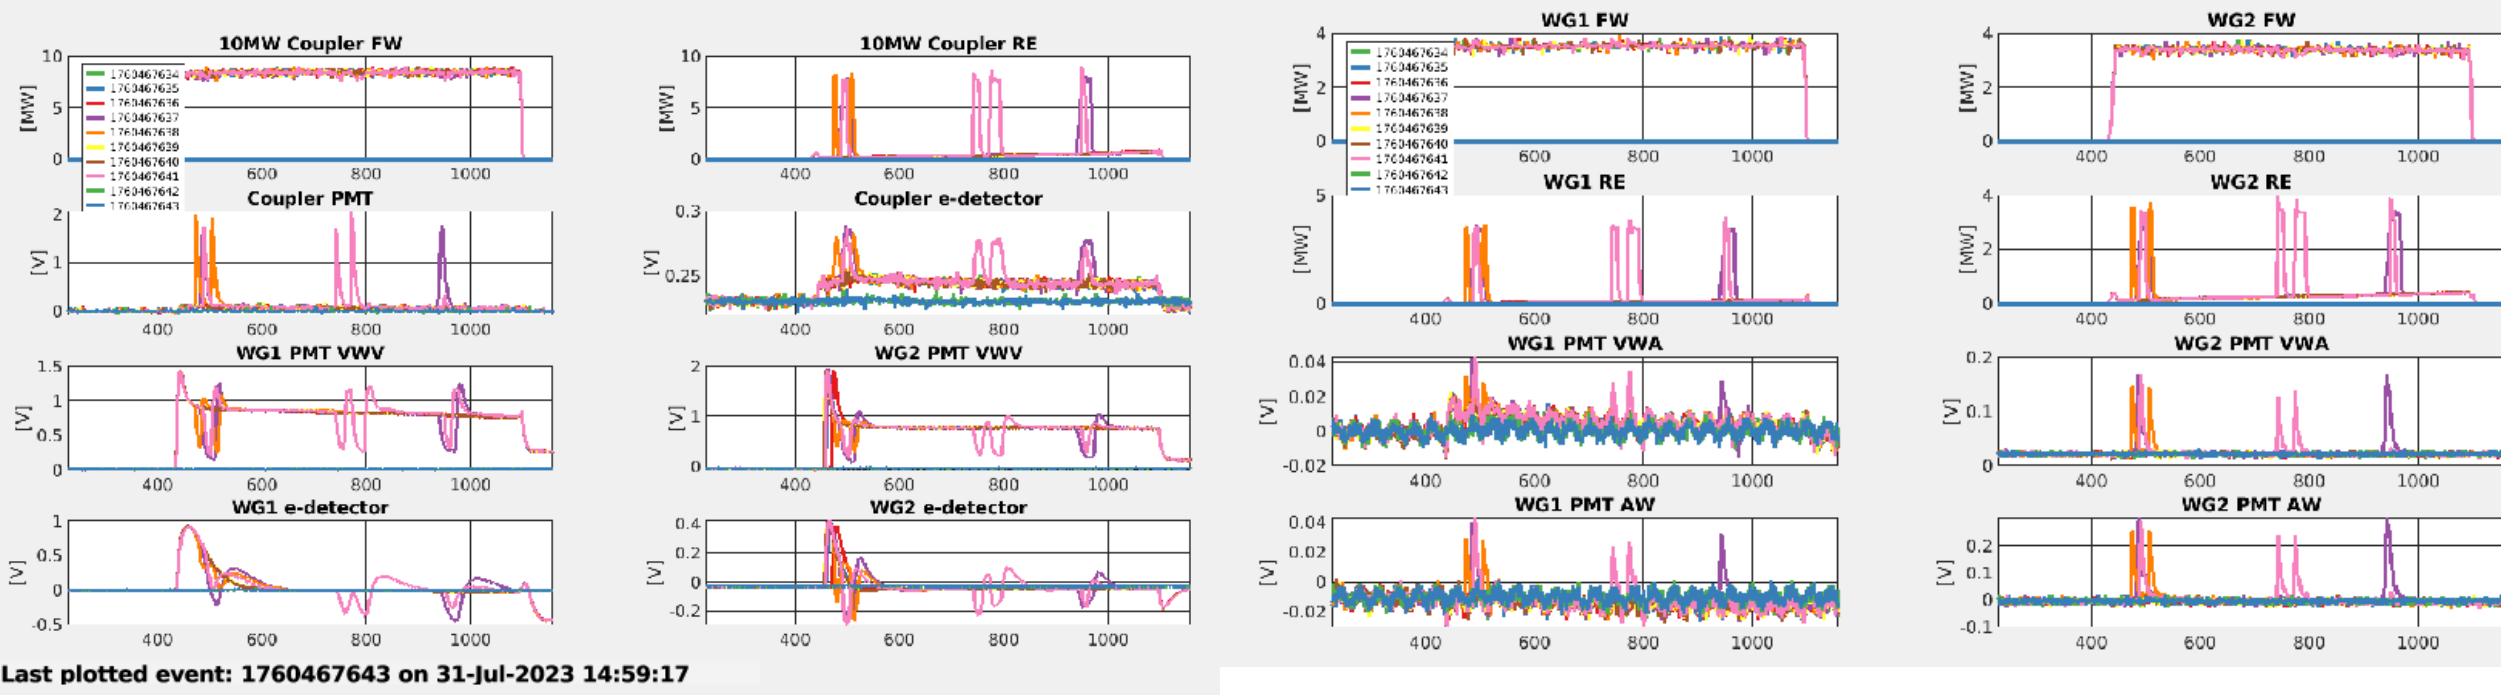
## 1<sup>st</sup> Gun trip investigation with LILI

NB: The RF probe was disconnected from measurements at this time for bias voltage tests

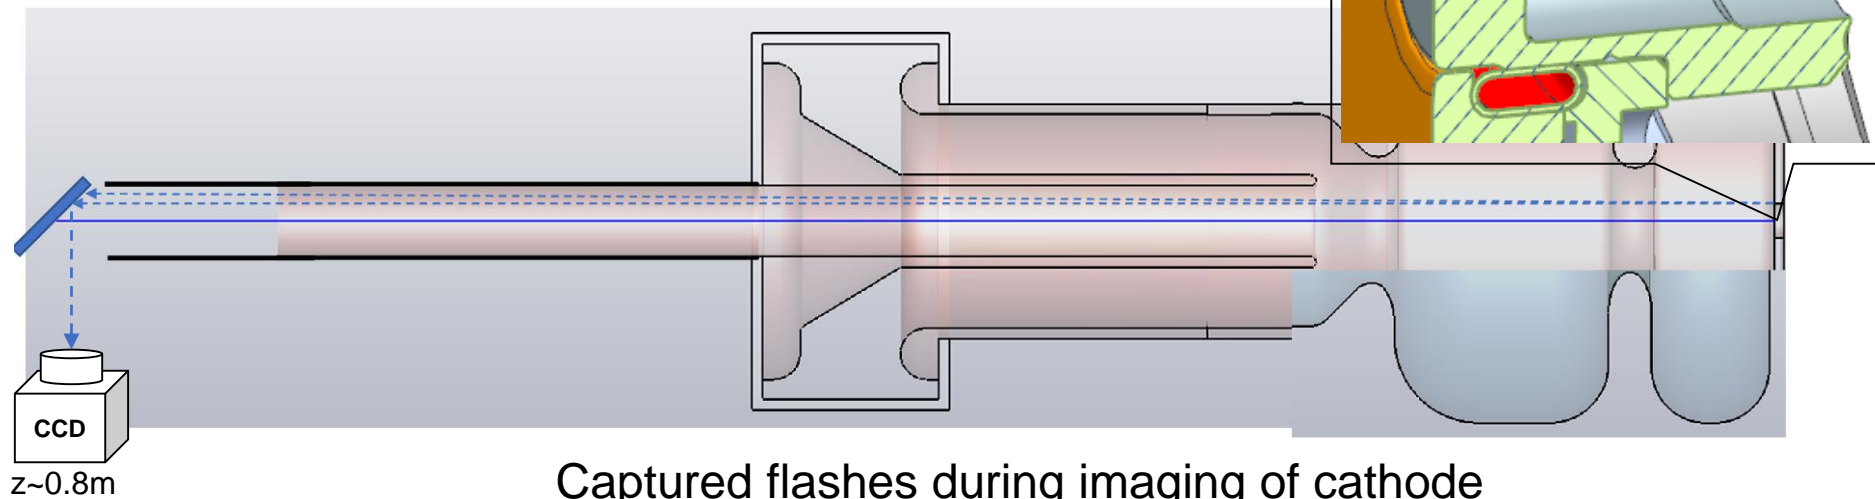
Frequent light seen at the cathode

Captured flashes during imaging of cathode

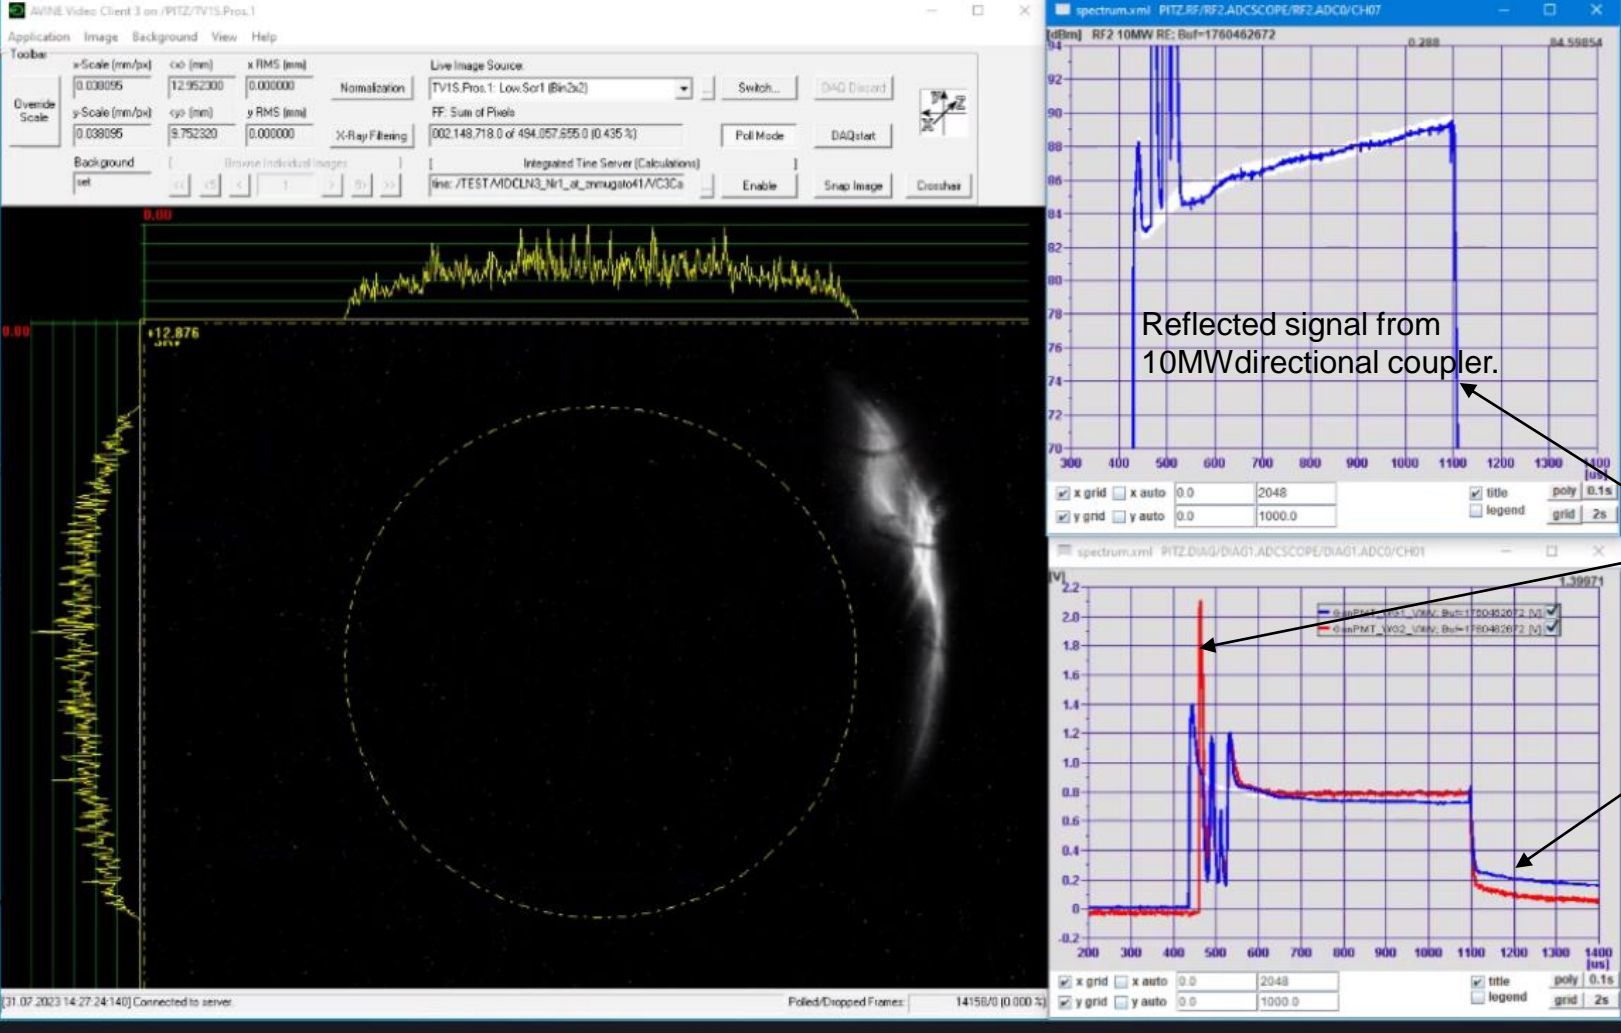
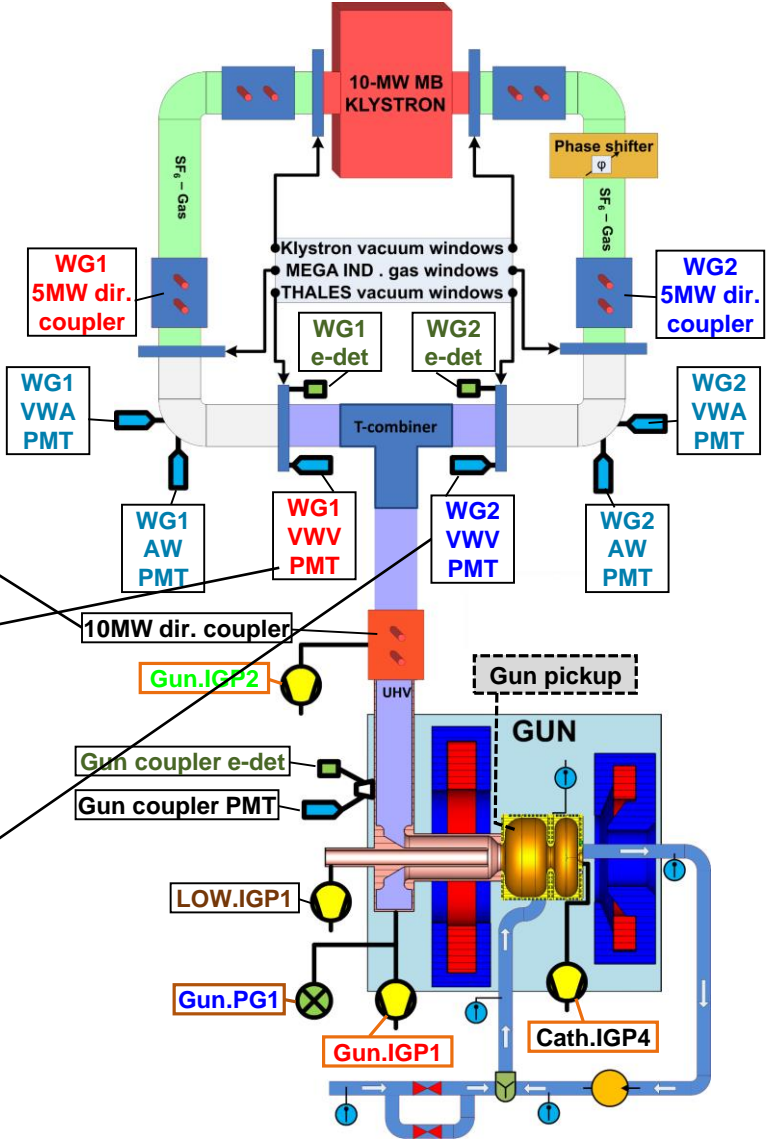
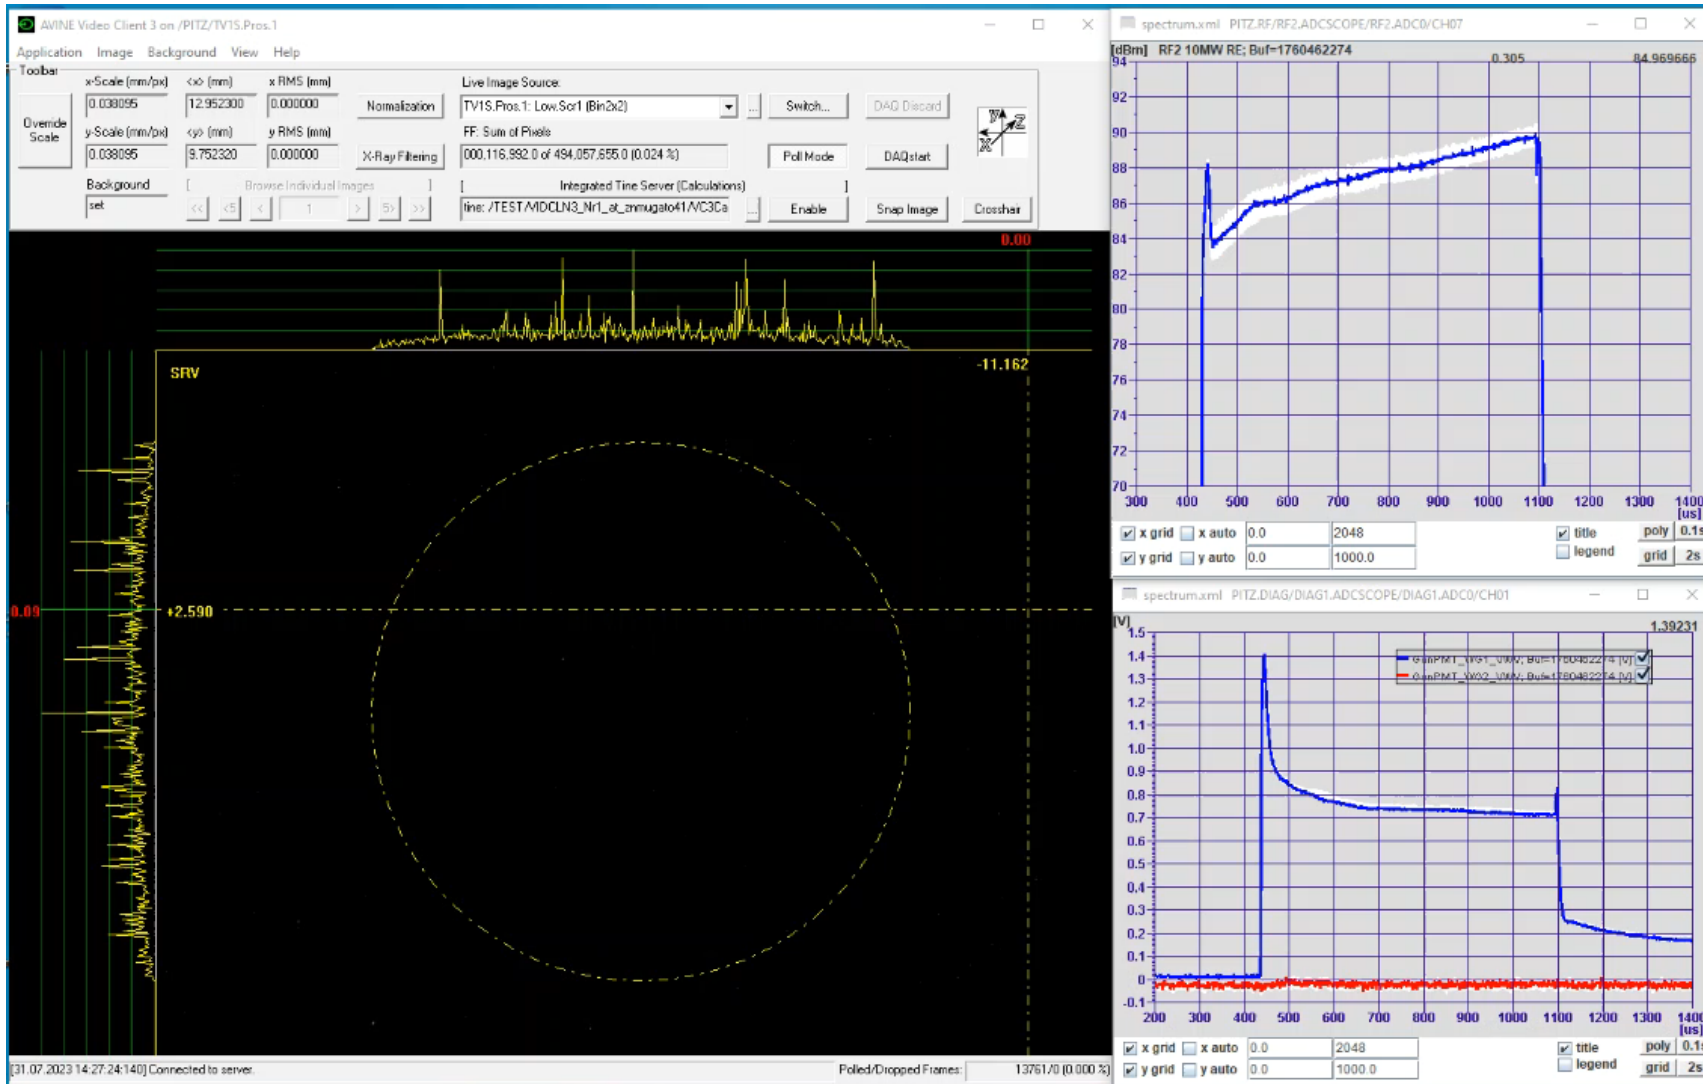
Flashes are correlated with RF signals distortion

These distortions are seen by other detectors as well:

→“gamma-bursts” related to RF pulse interruptions are observed by many detectors (e.g. booster spark PDs)!

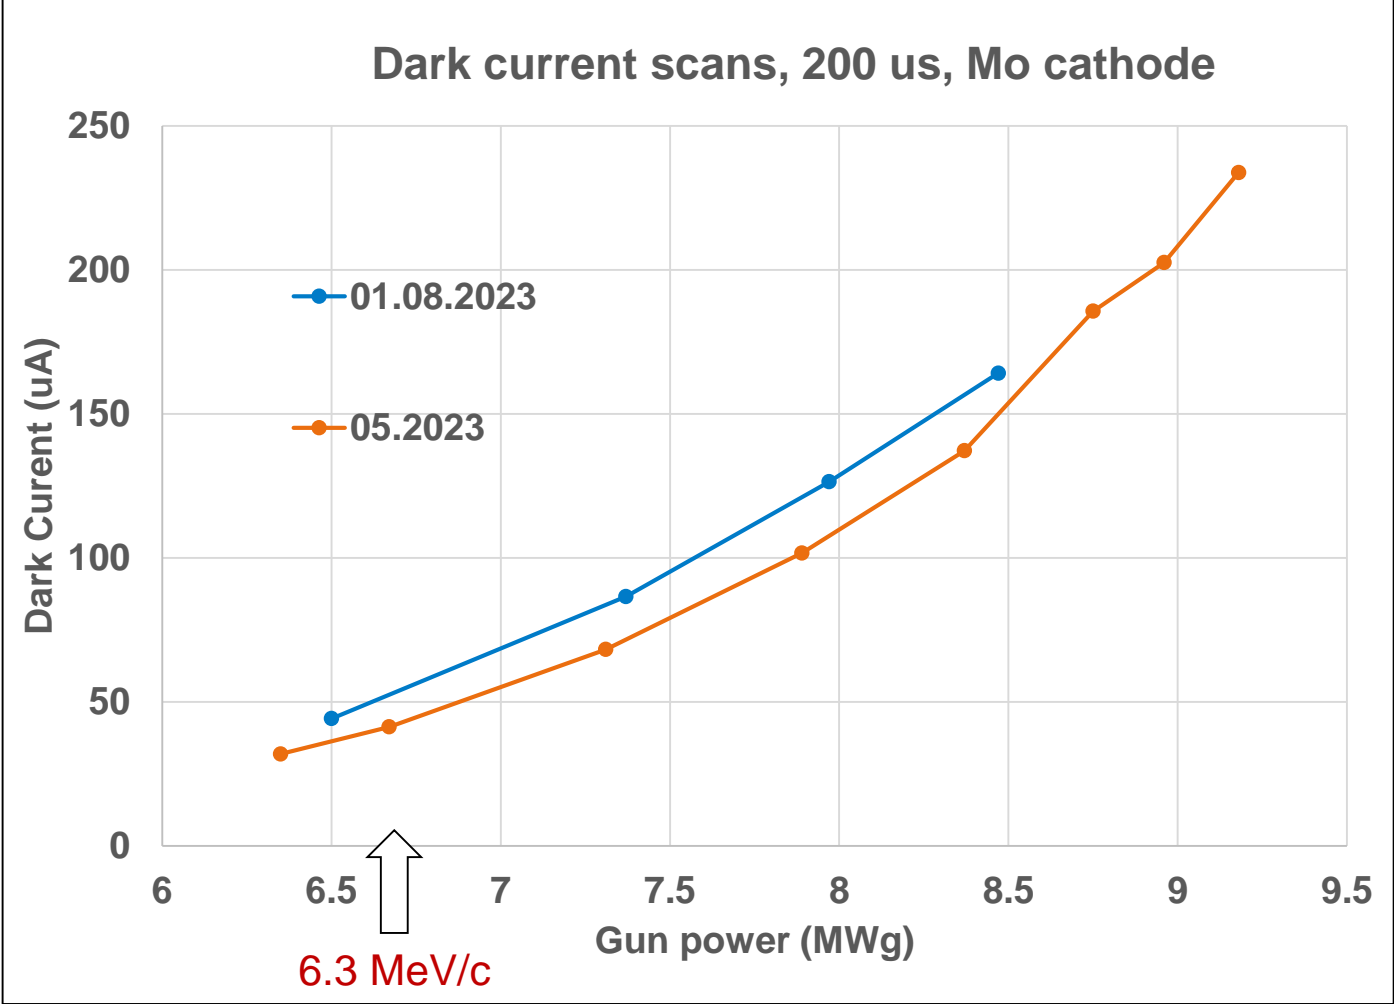
# Dark current

Even after problems started – no significant increase!

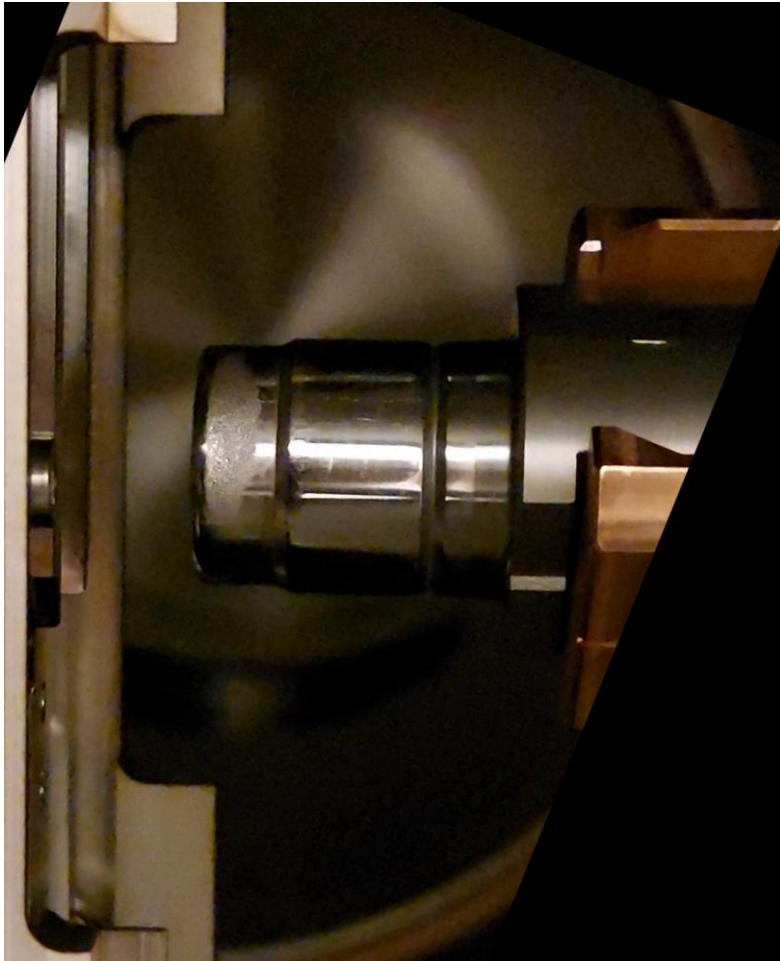
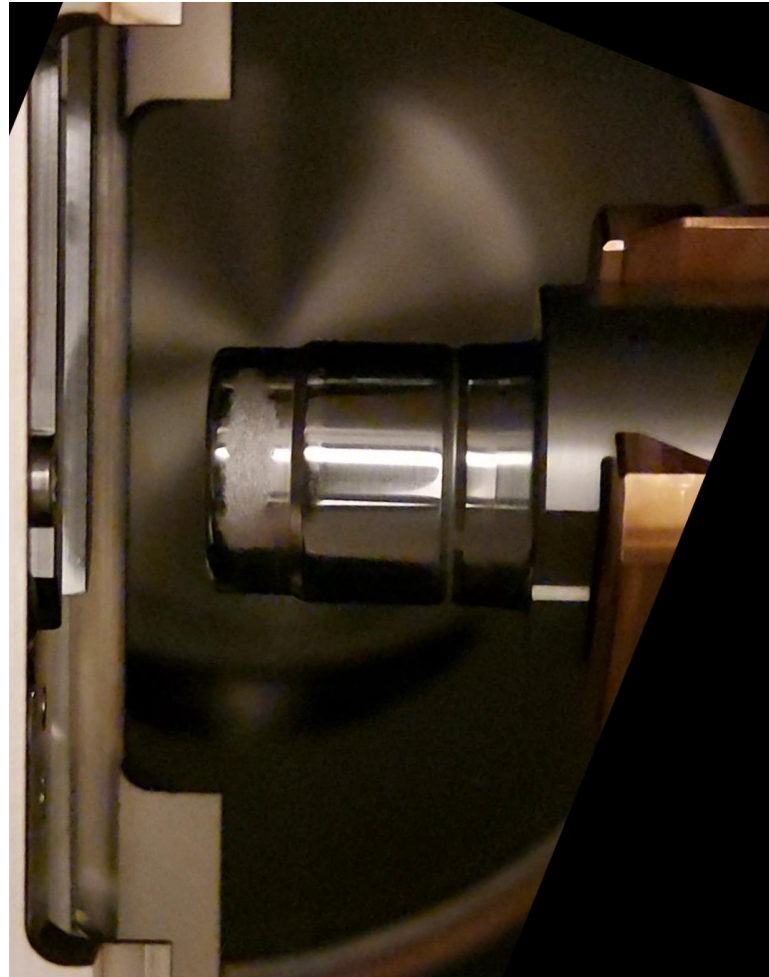
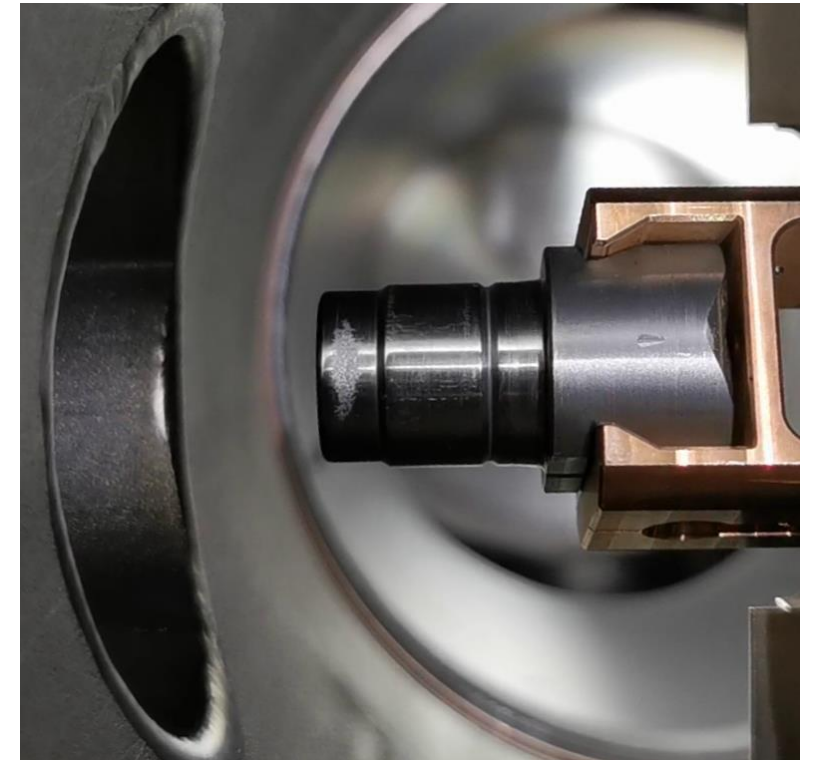
Damage observed on the side surface of extracted cathodes (Mo#741.1 and Cs2Te#693.1)

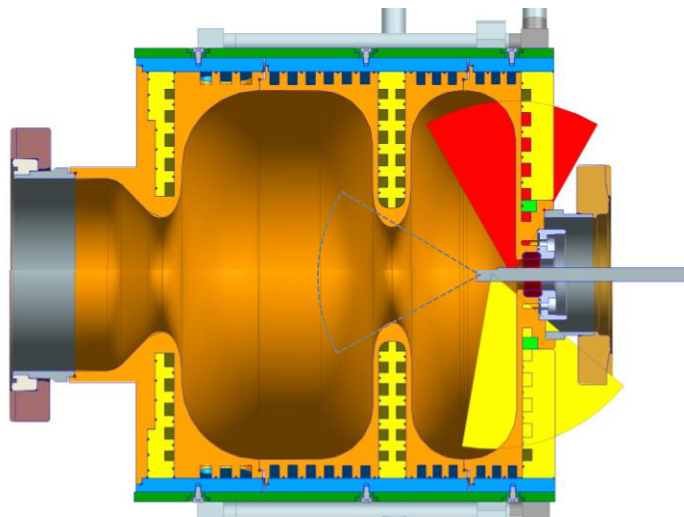
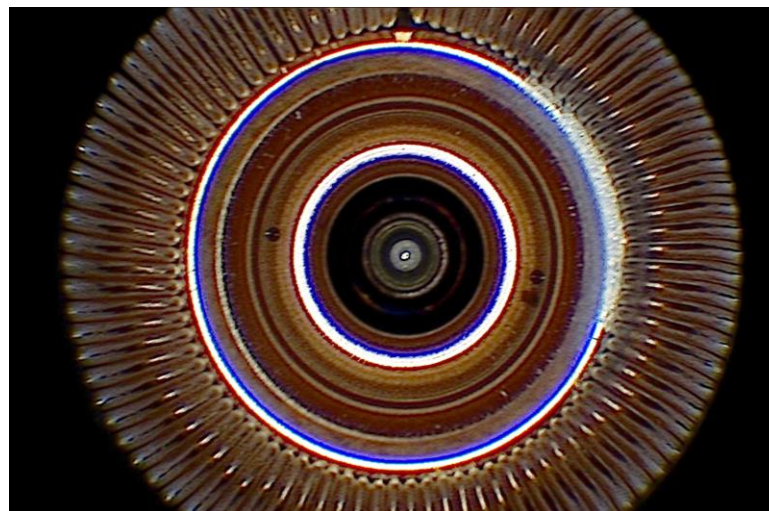
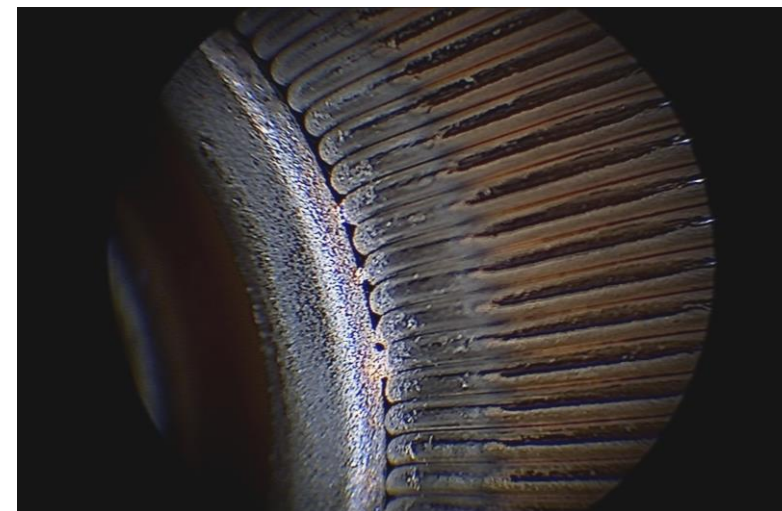
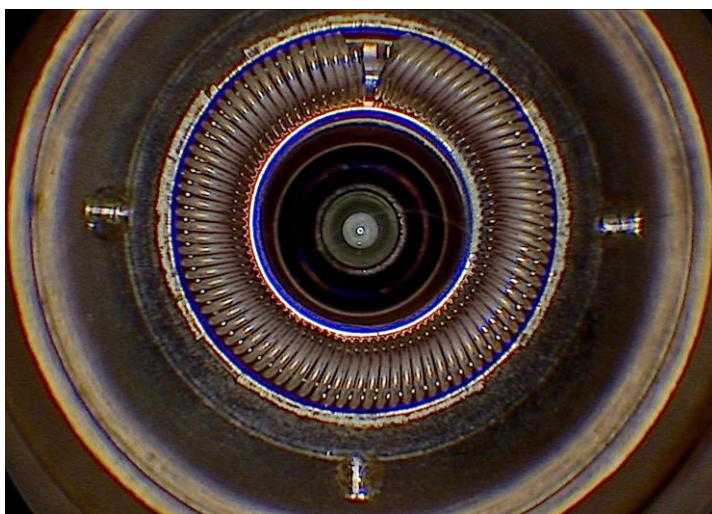
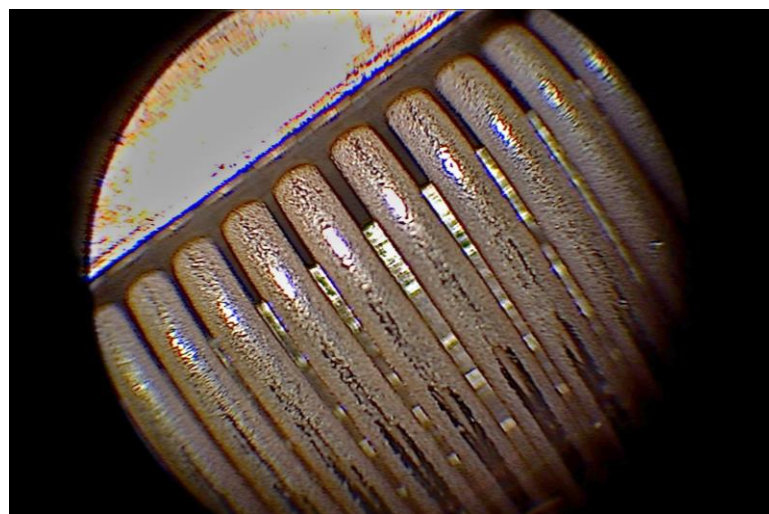
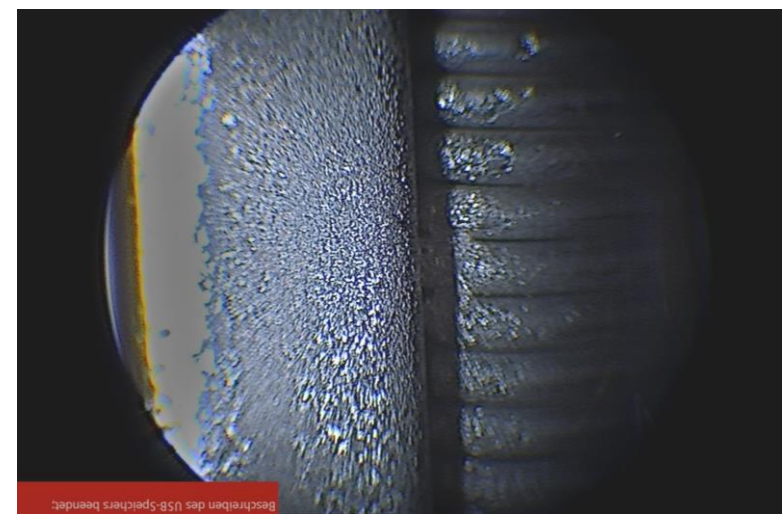
Gun opened from the back (cathode) side, visual inspections on 18.08.2023 and on 23.08.2023

- Cathode side surface damage observed
- Upon opening the gun:
  - severe damage to the cathode contact spring and surrounding area observed
  - but RF pickup in the full cell looks OK

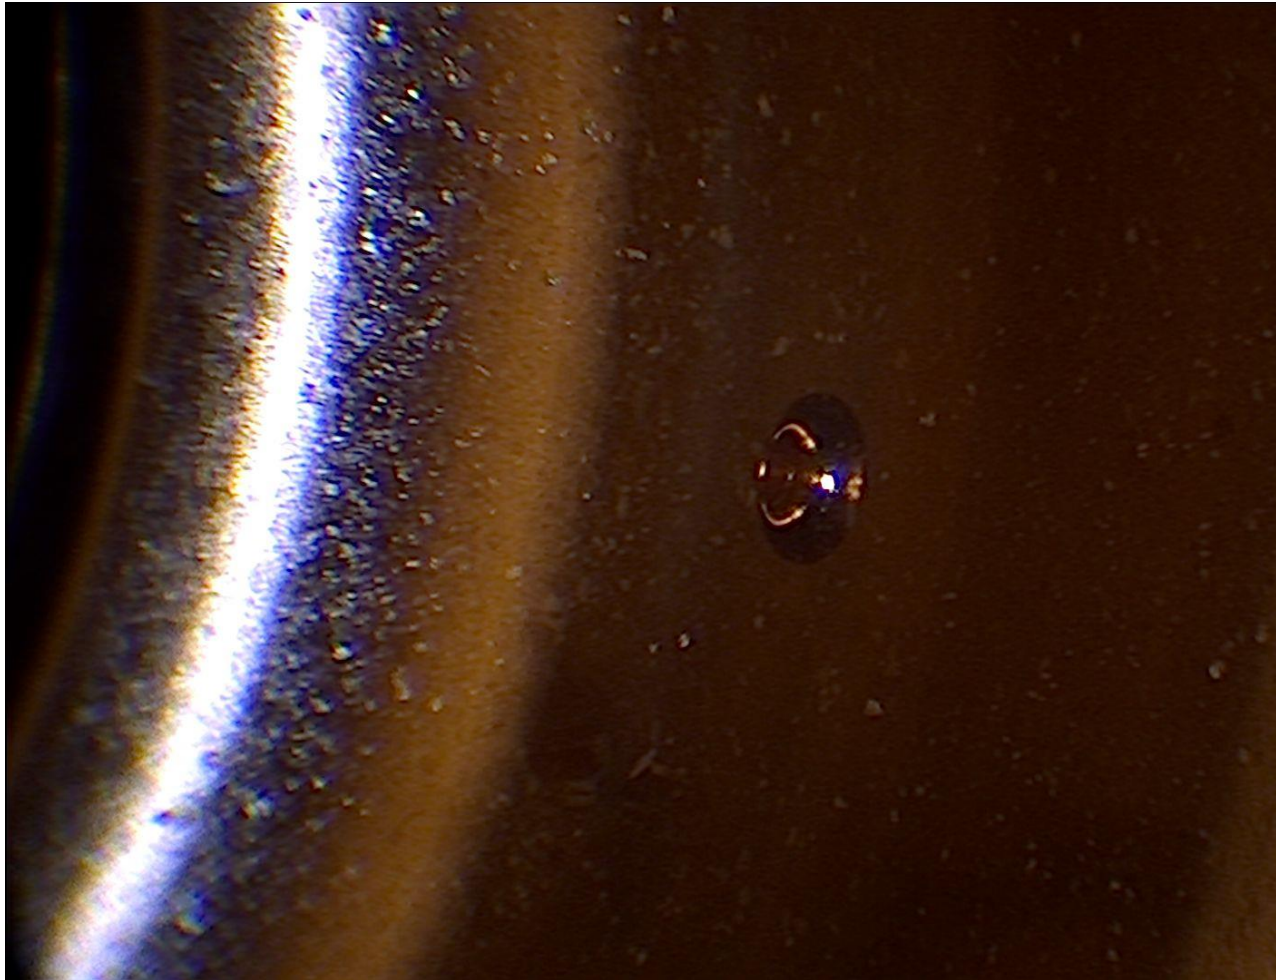
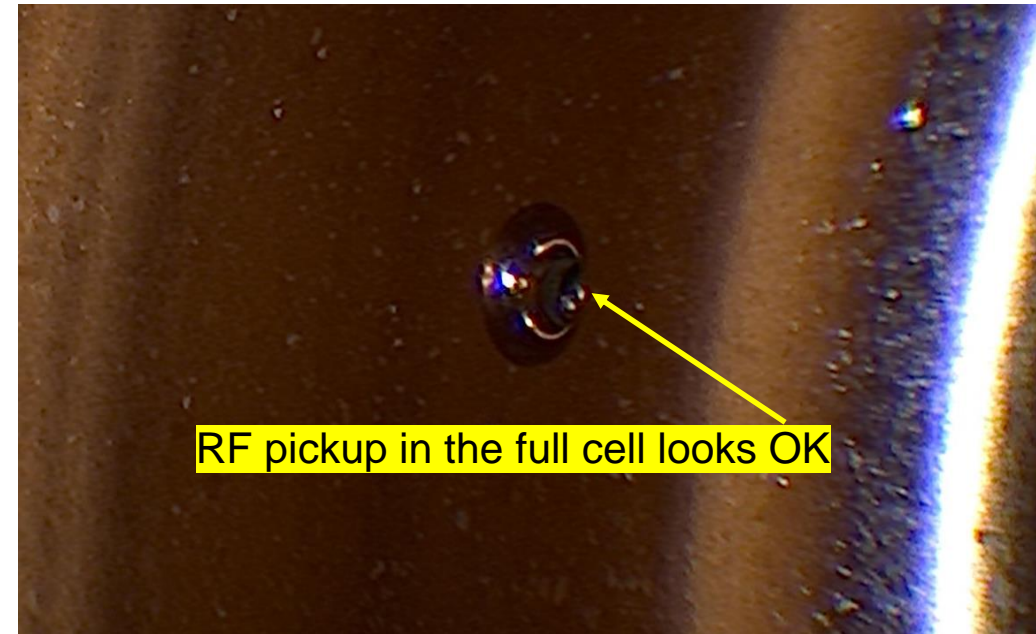
Gun video inspection on 23.08.2023: positive message – no damage observed on the RF pickup

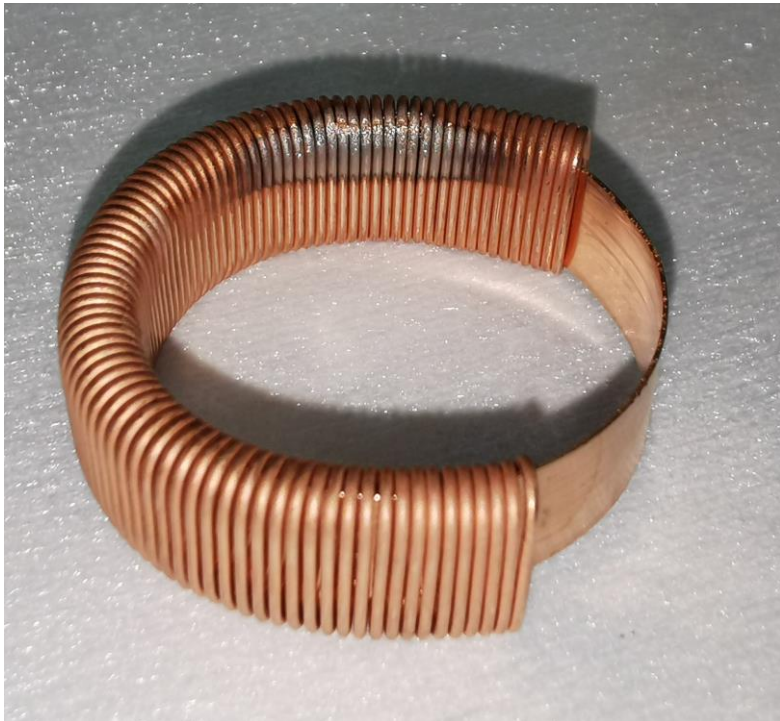
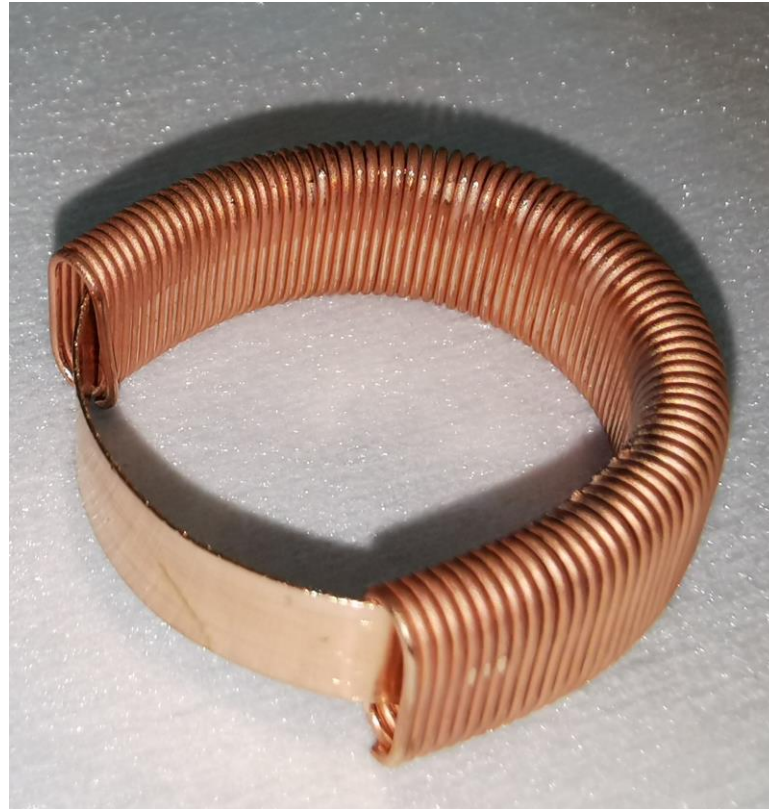
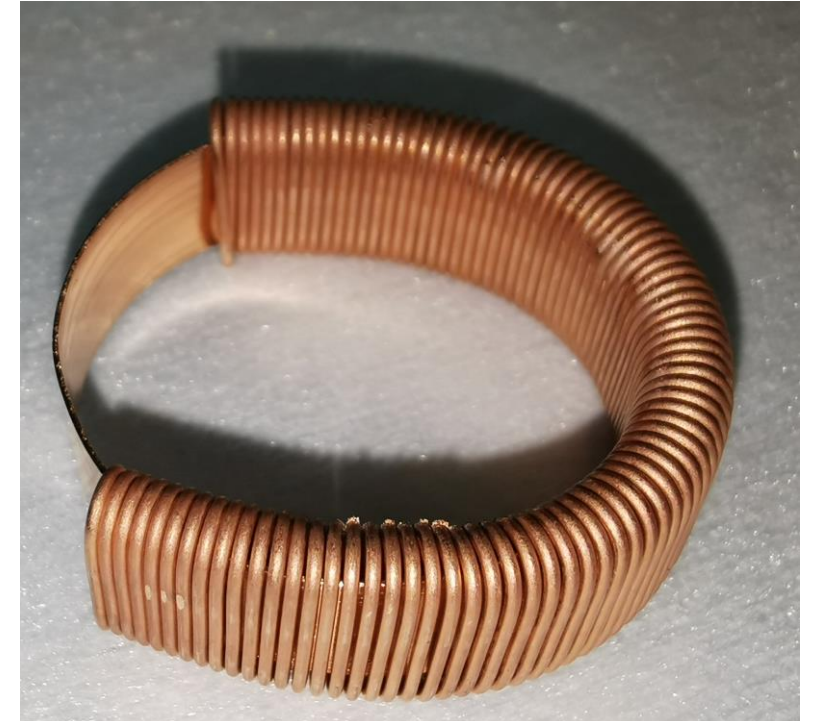
Damages contact spring removed
