# PITZ Experience with Gun5.1

Gun5 measurements and Status of L-Band conditioning facility

Mikhail Krasilnikov for the PITZ team  
XFEL MAC, 08.11.2023

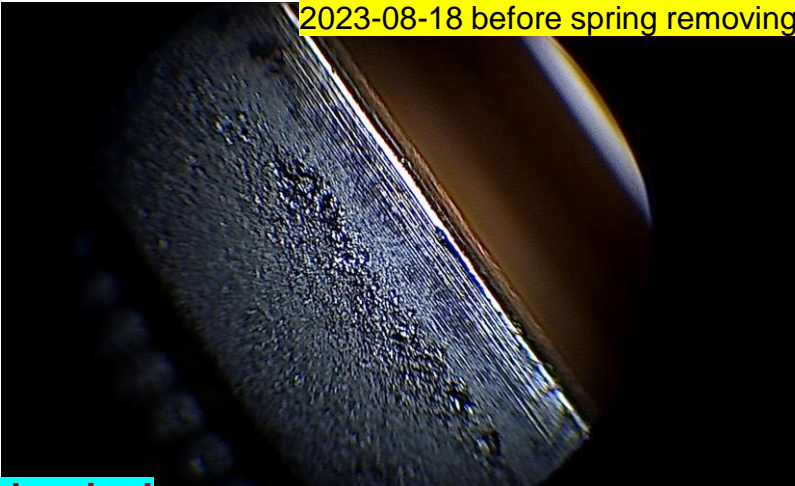
2023-08-18 before spring removing

- Polishing
- 6x Grit 1000
  - 1x Grit 1500
  - 1x Grit 2000

**NB: no dry ice cleaning!**

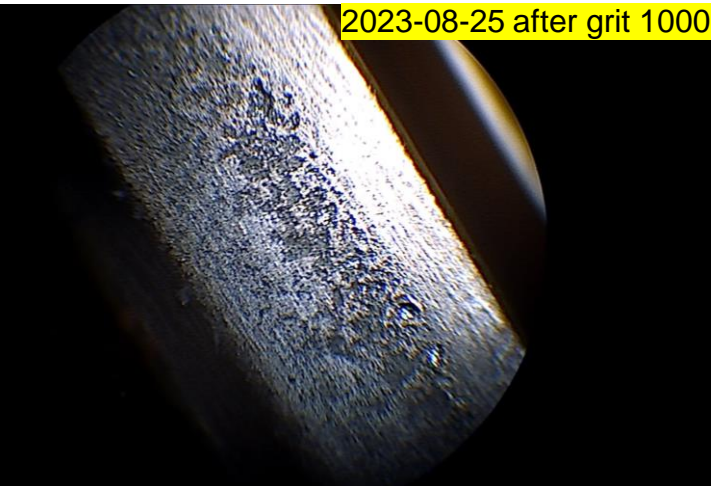
2023-08-25 after grit 1000

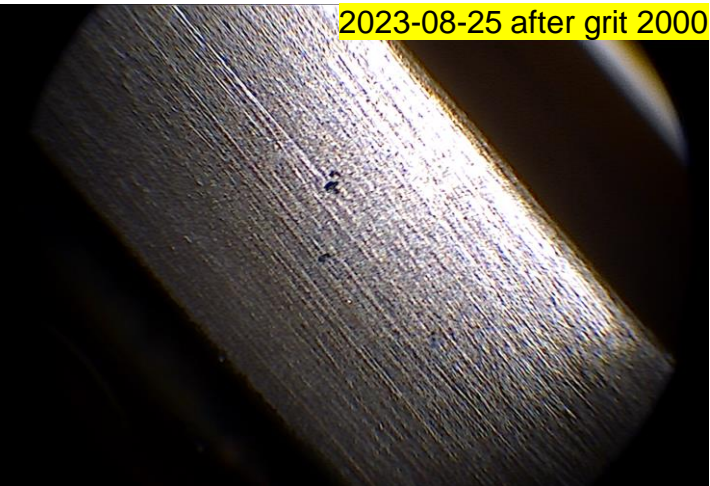
2023-08-25 after grit 2000

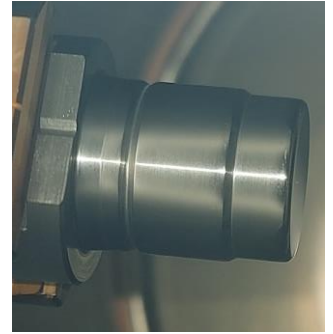
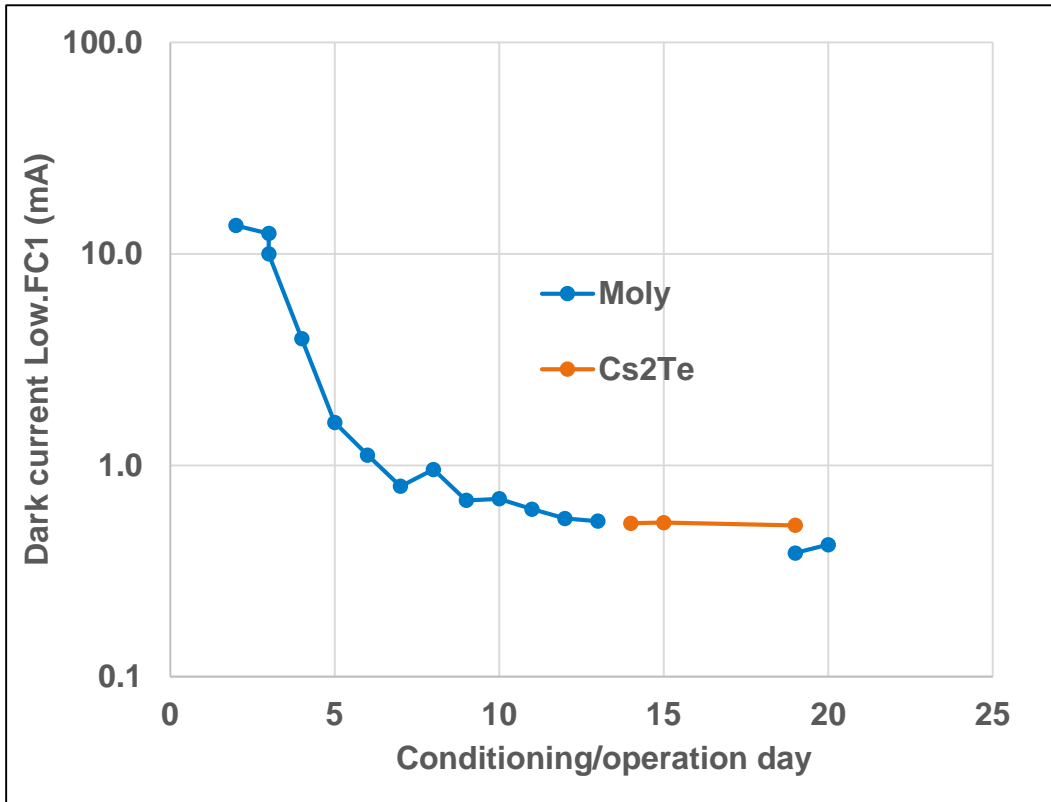
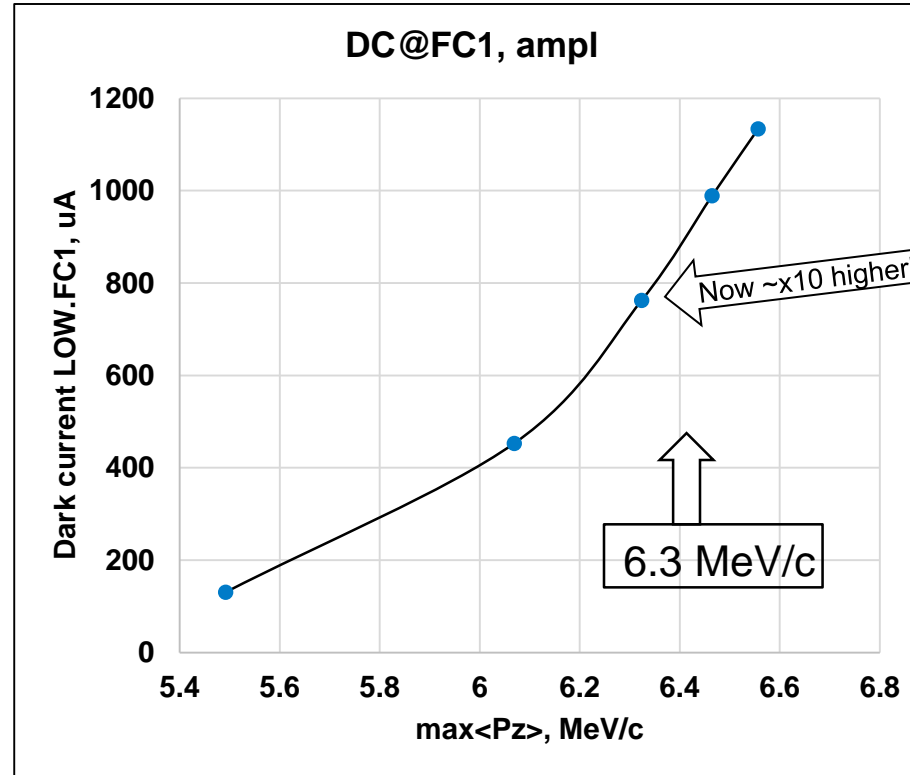
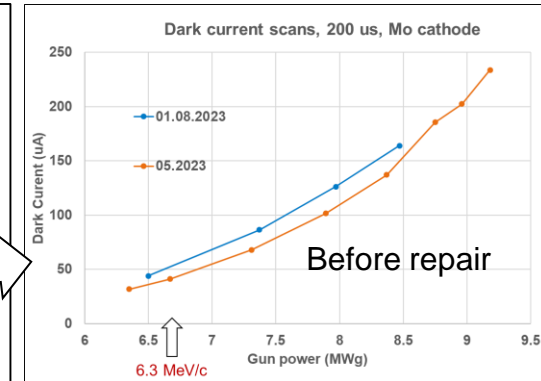
## Observations during reconditioning

- **Extremely high dark current** (~mA at 6.7MWg), but reduced with conditioning
- Strong multipacting (MP) observed after main RF pulse → looks like conditioned out now
- No damage of cathode Mo plug after several weeks of conditioning

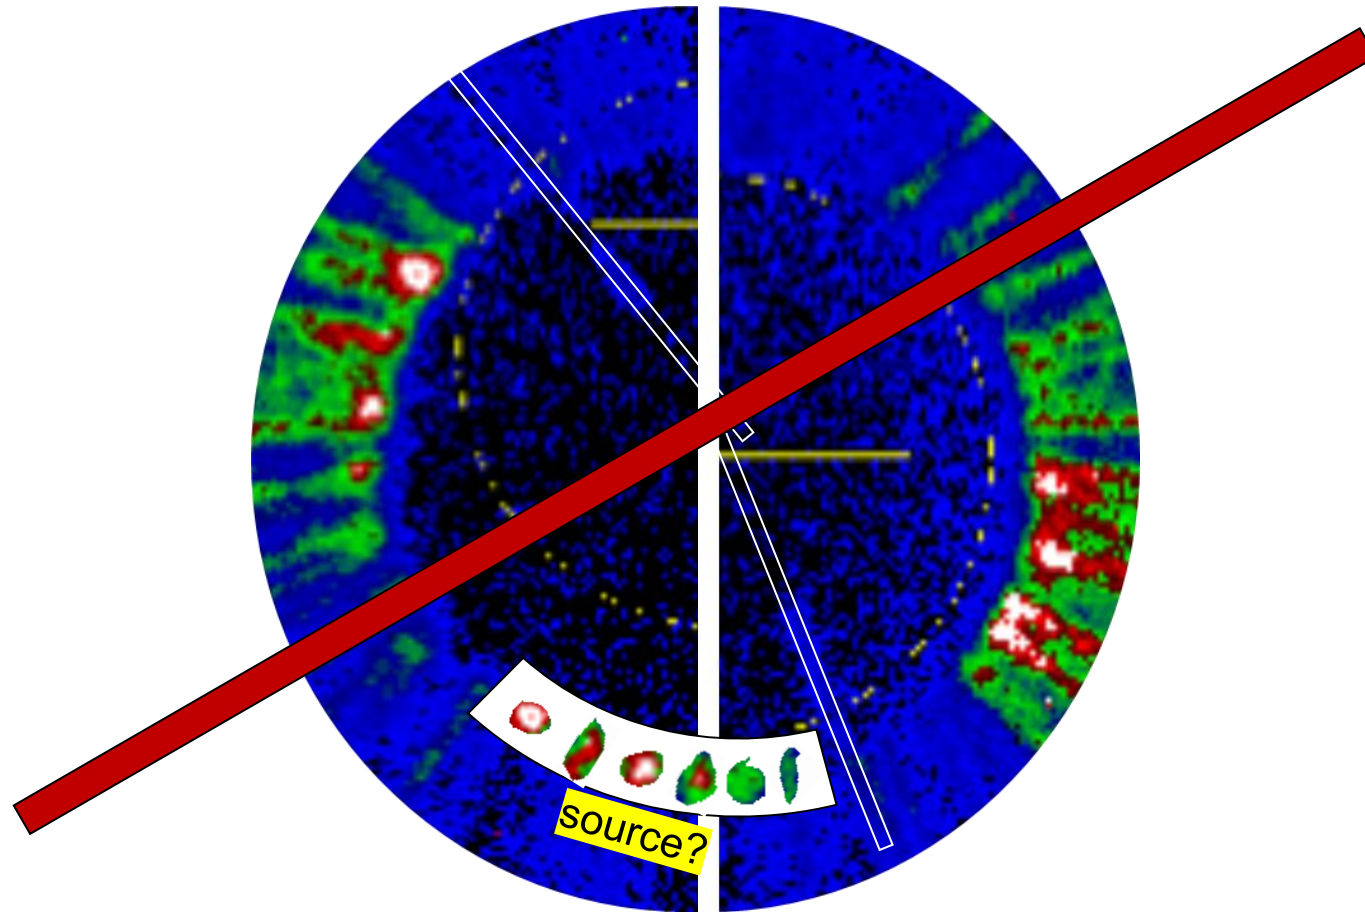
Dark current imaging: looking for a FE source

- Re-conditioning started on 12.09.2023:
  - No cathode side surface damage observed
  - Significant dark current:
    - x10 higher than before
    - Source is most probably – still contact spring area
