Defective Camera Effects - PPS

Comparative measurement of defective Proscilica cameras

James Good
PPS-Meeting
Zeuthen, 18.02.2016,

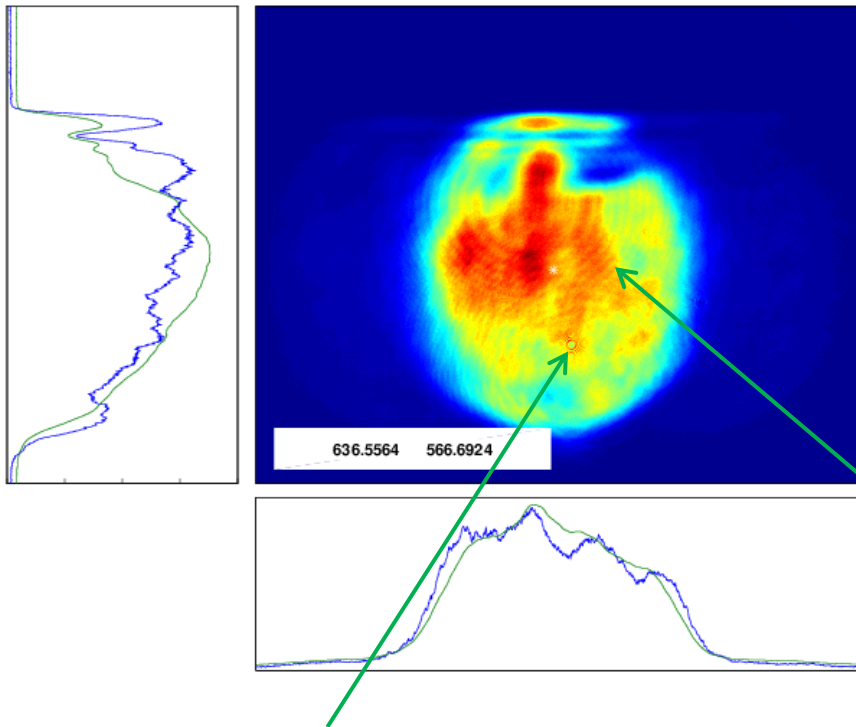
Reference Camera

SNR: Excellent

> Note dust particles interference rings from ND filters

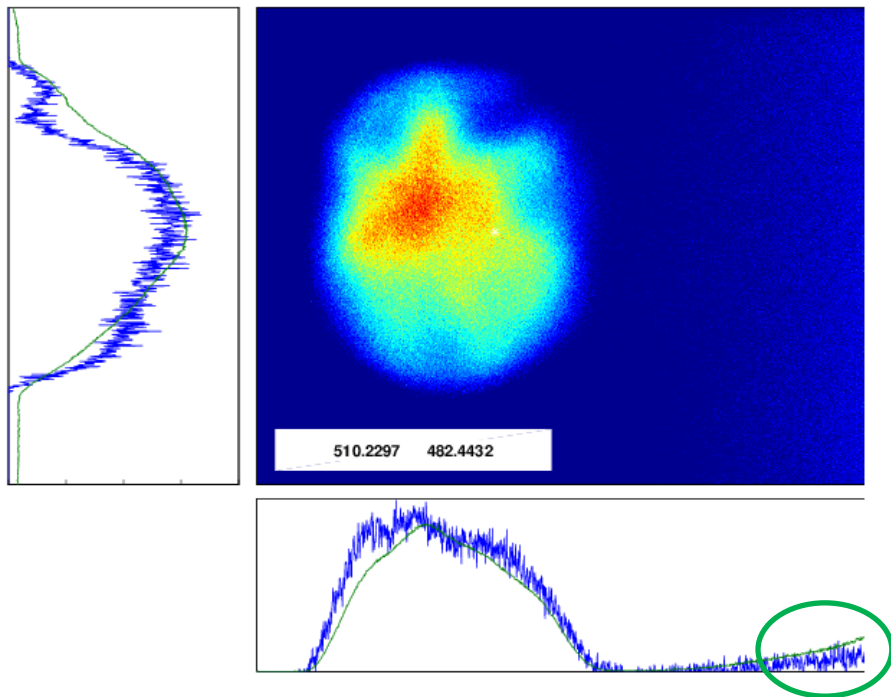
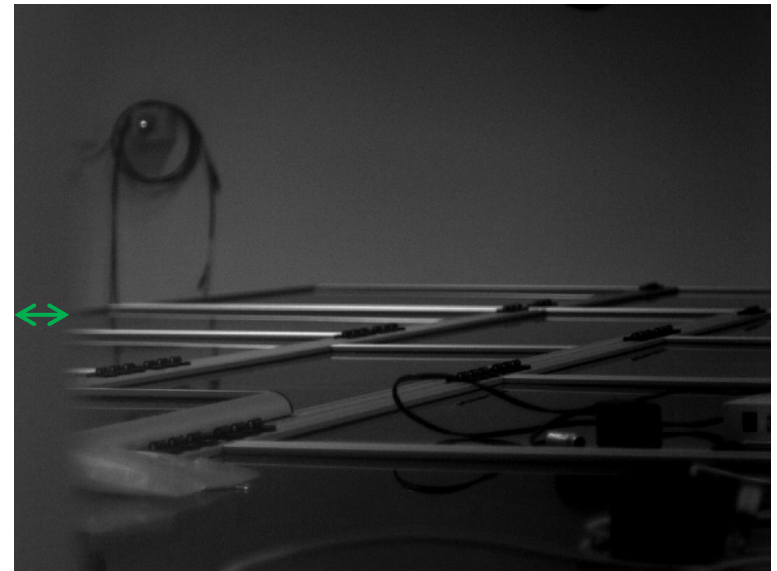
Disposable Camera #1

SNR: V. Bad

- Note the characteristic edge slope in the cross-section
- Visually okay in visible. Low QE?

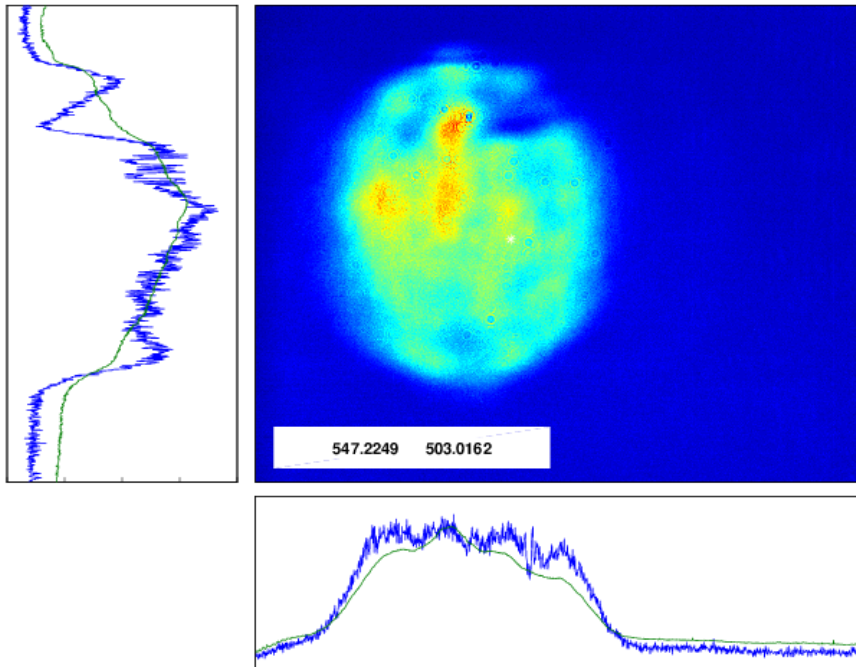
Disposable Camera #2

SNR: Okay

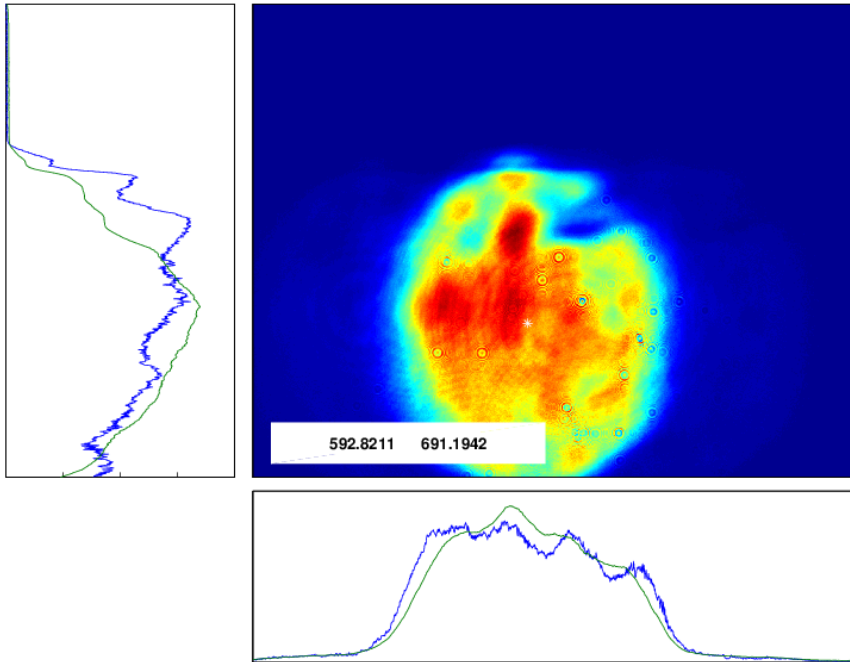
Disposable Camera #4

SNR: Good

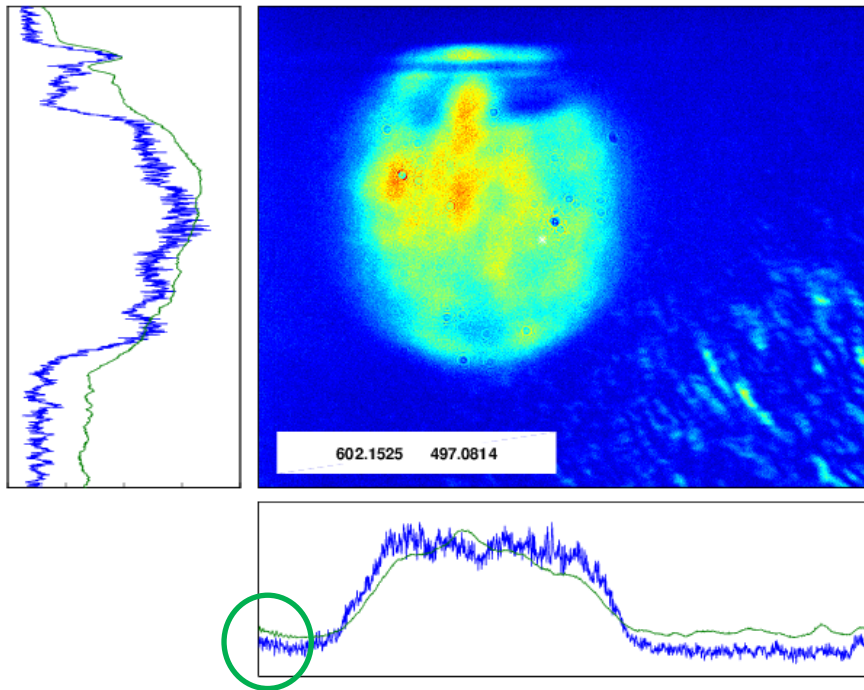
Disposable Camera #5

SNR: Okay

Location: ELLA C1 (pinhole)

- Note small edge slope in the cross-section
- Background noise due to physical damage
