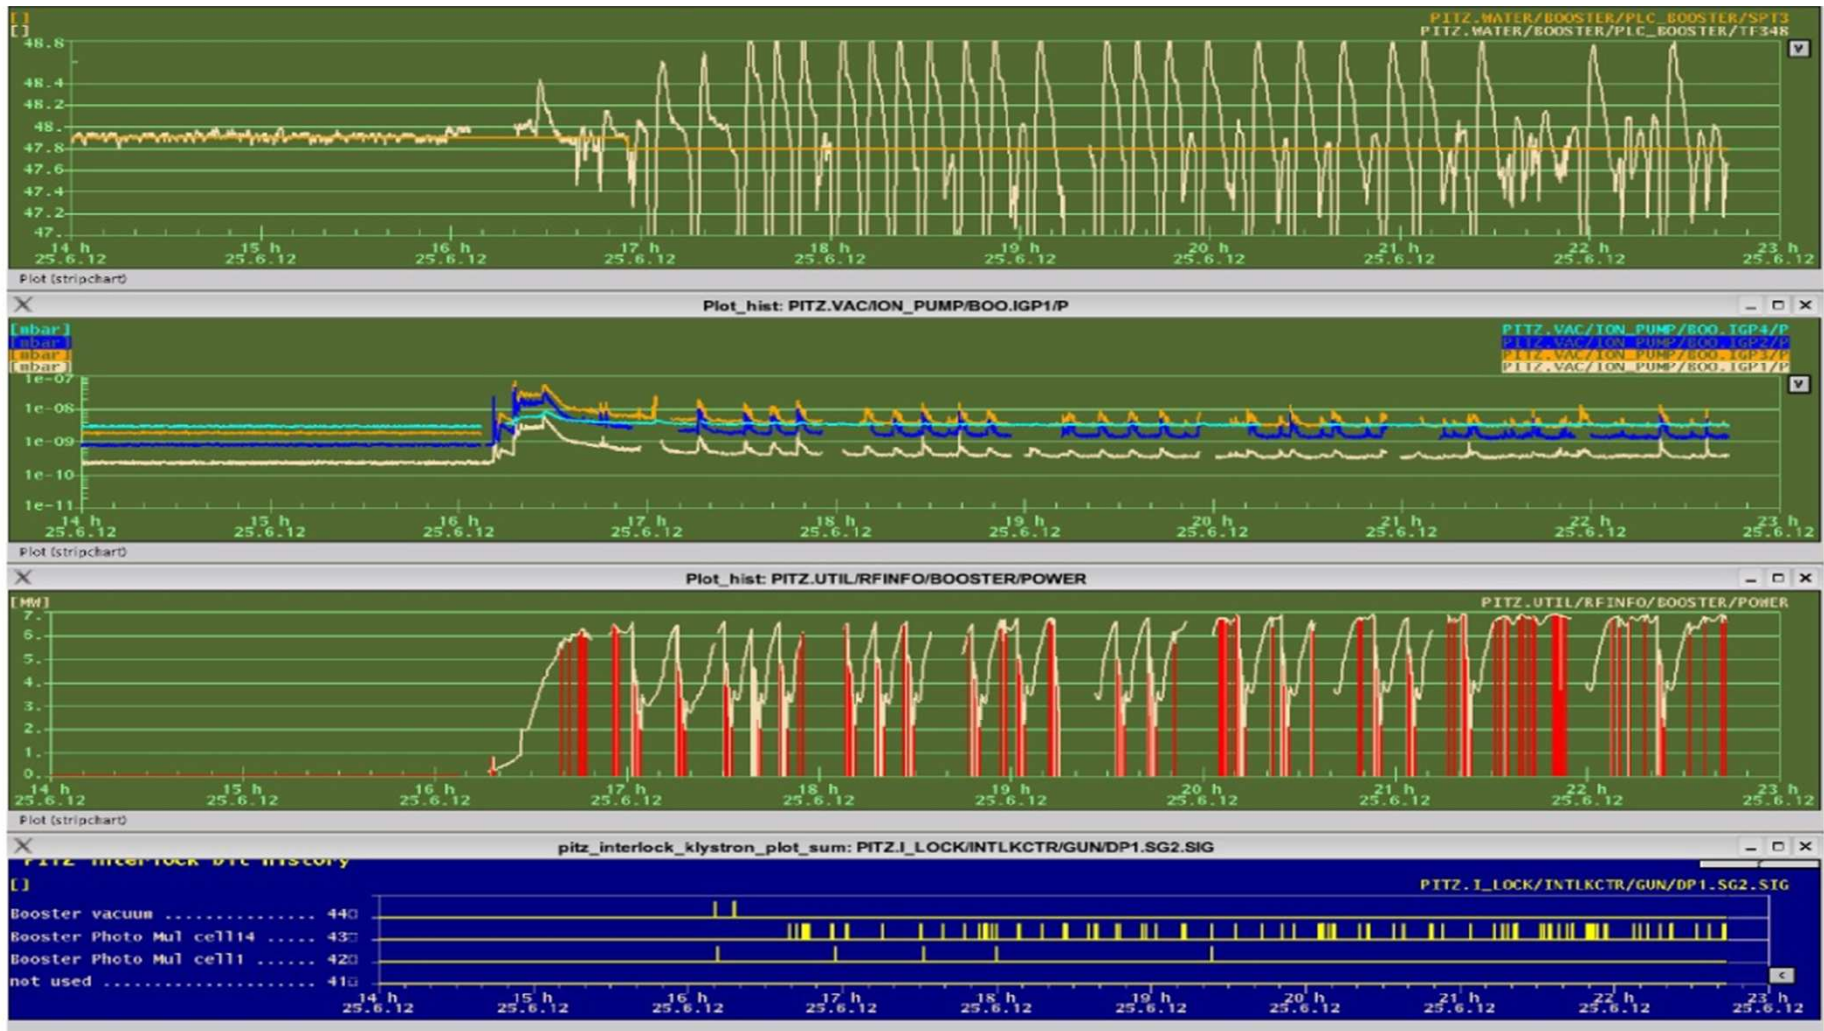
100 us pulse duration

Full power reached, but stable for very short time

At the same time no significant vacuum activity, only light

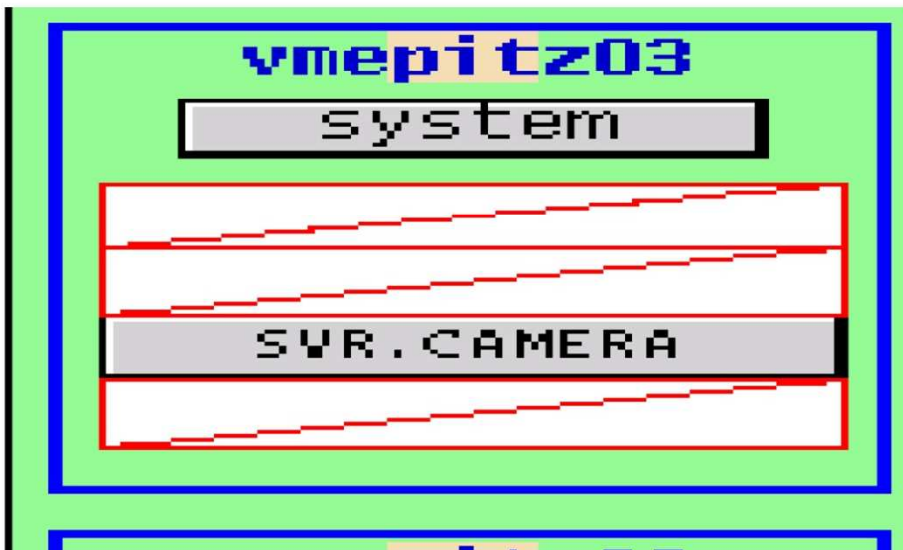
Problem with vmepitz03 happens to often last several months. The replacement for vmepitz03 has to be planned. The problem that such type of hardware is not produced anymore – new hardware type will need significant changes in software

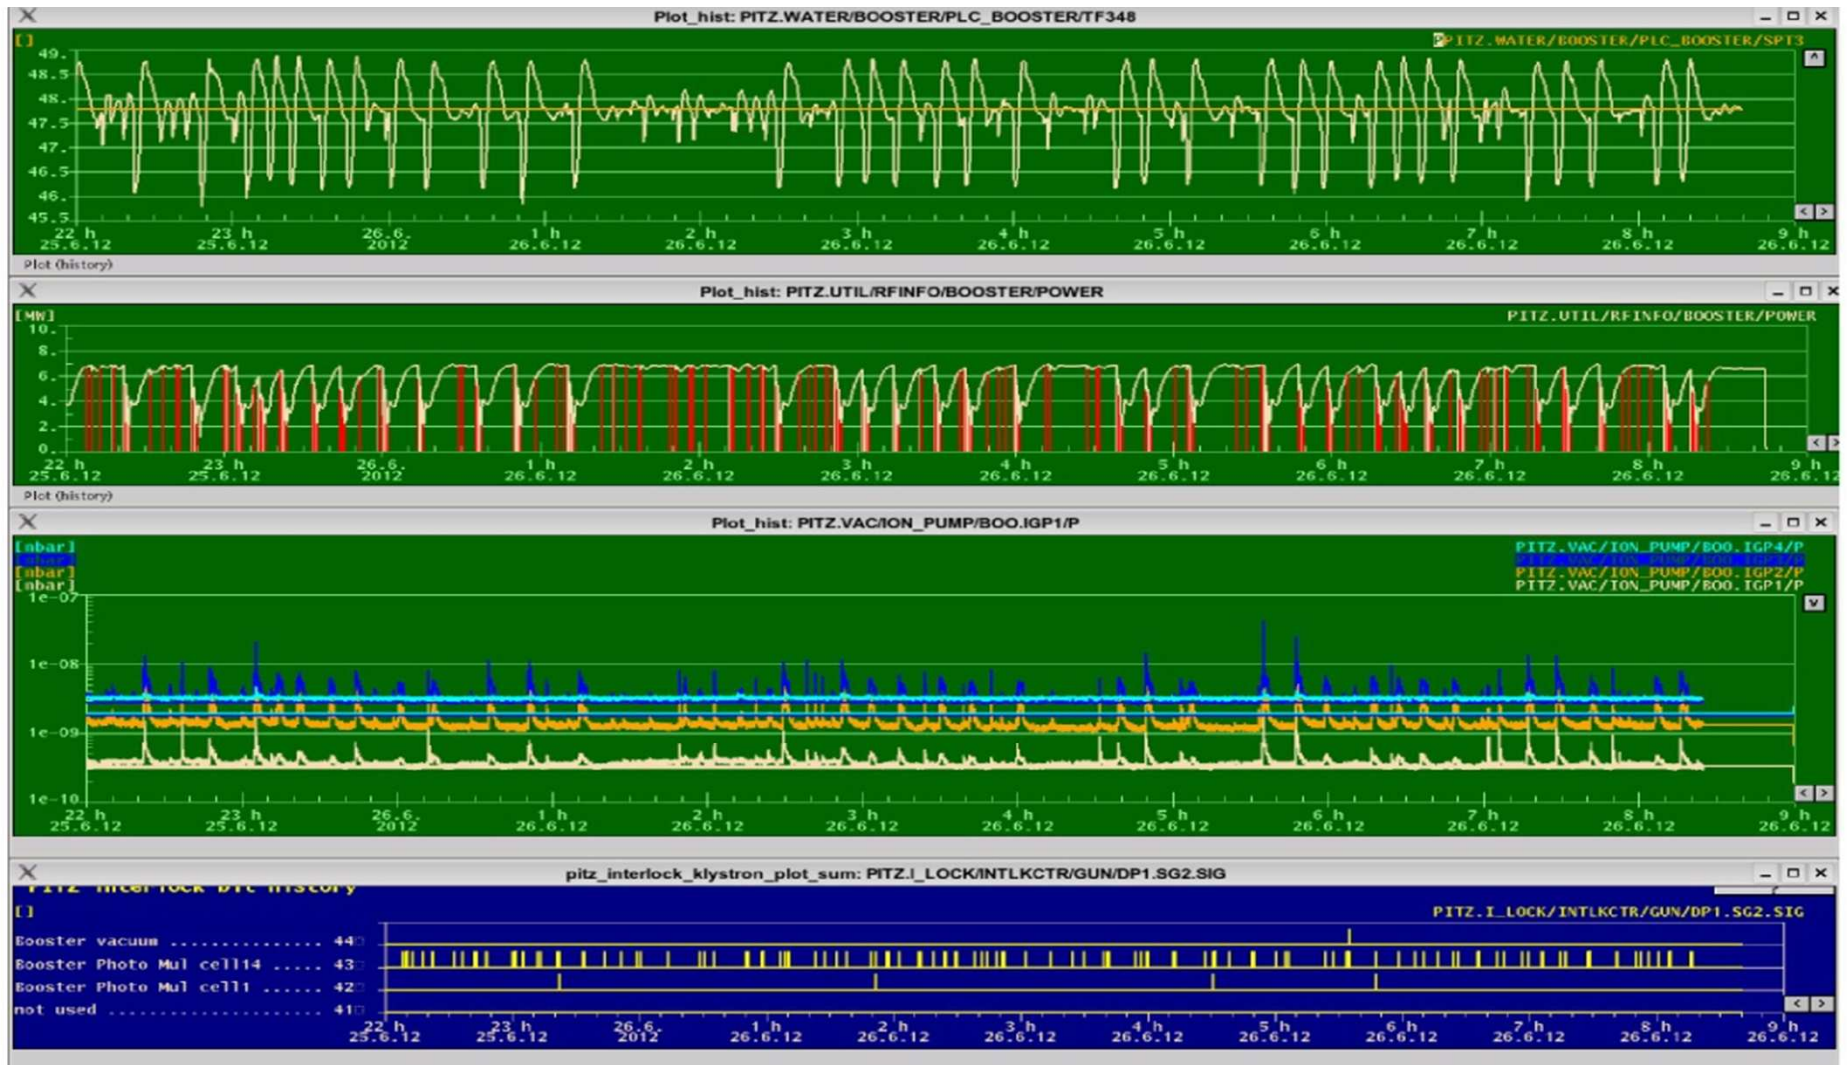
100 us pulse duration. After this the very high radiation level was measured – more then 300 uSv/h at Boo.V1.

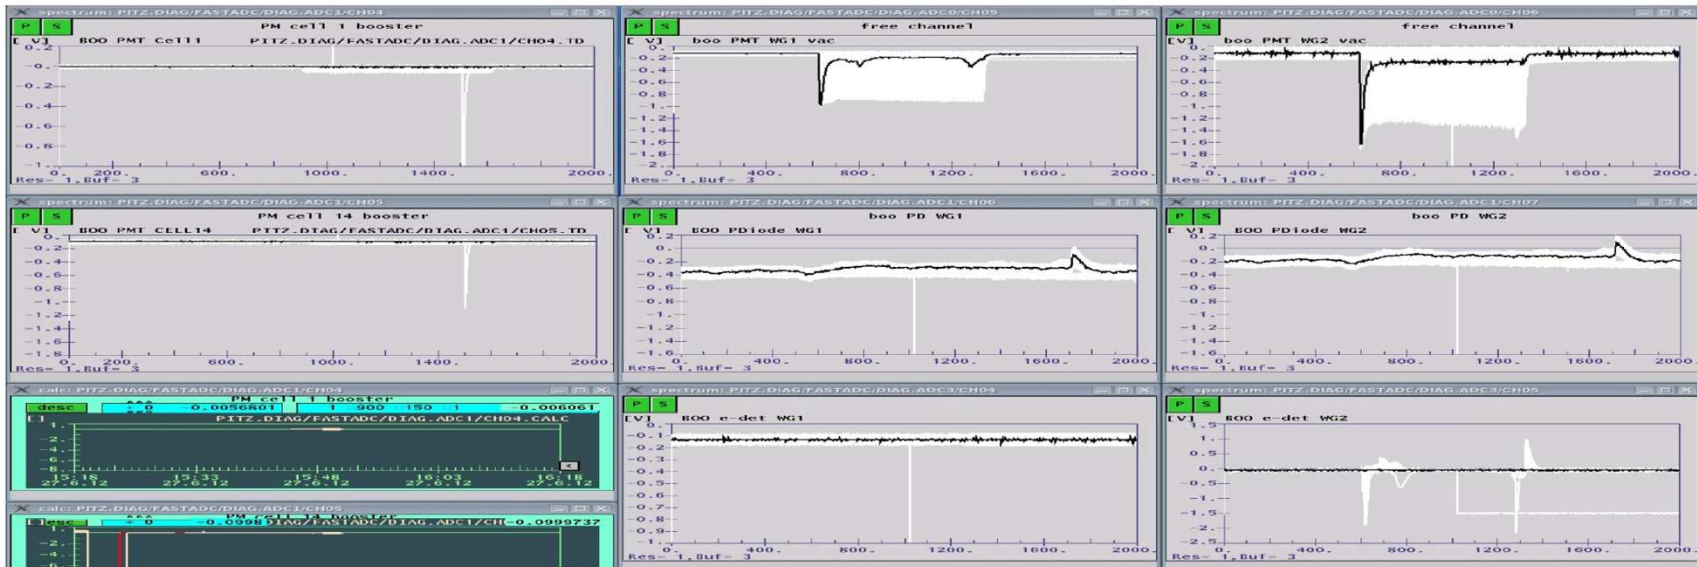
## Booster sensors readout at 3.5 MW @ 700 us, noisy signal on PMT in WG1

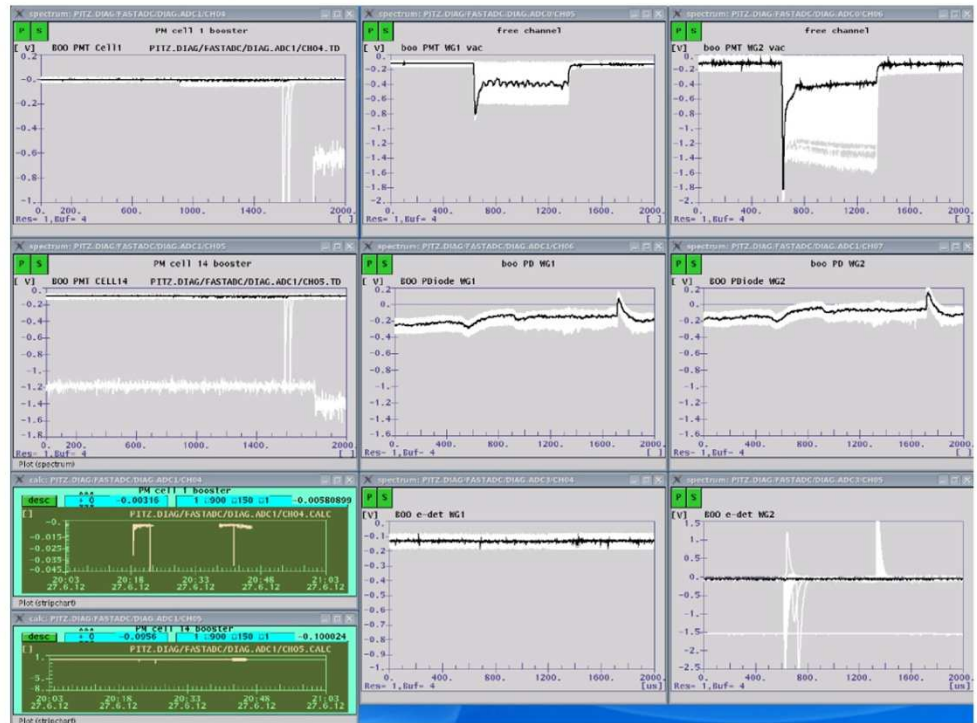
The horns at PMTs in WG1&2 a bit reduced after increasing of the filling time from 15 to 25 us

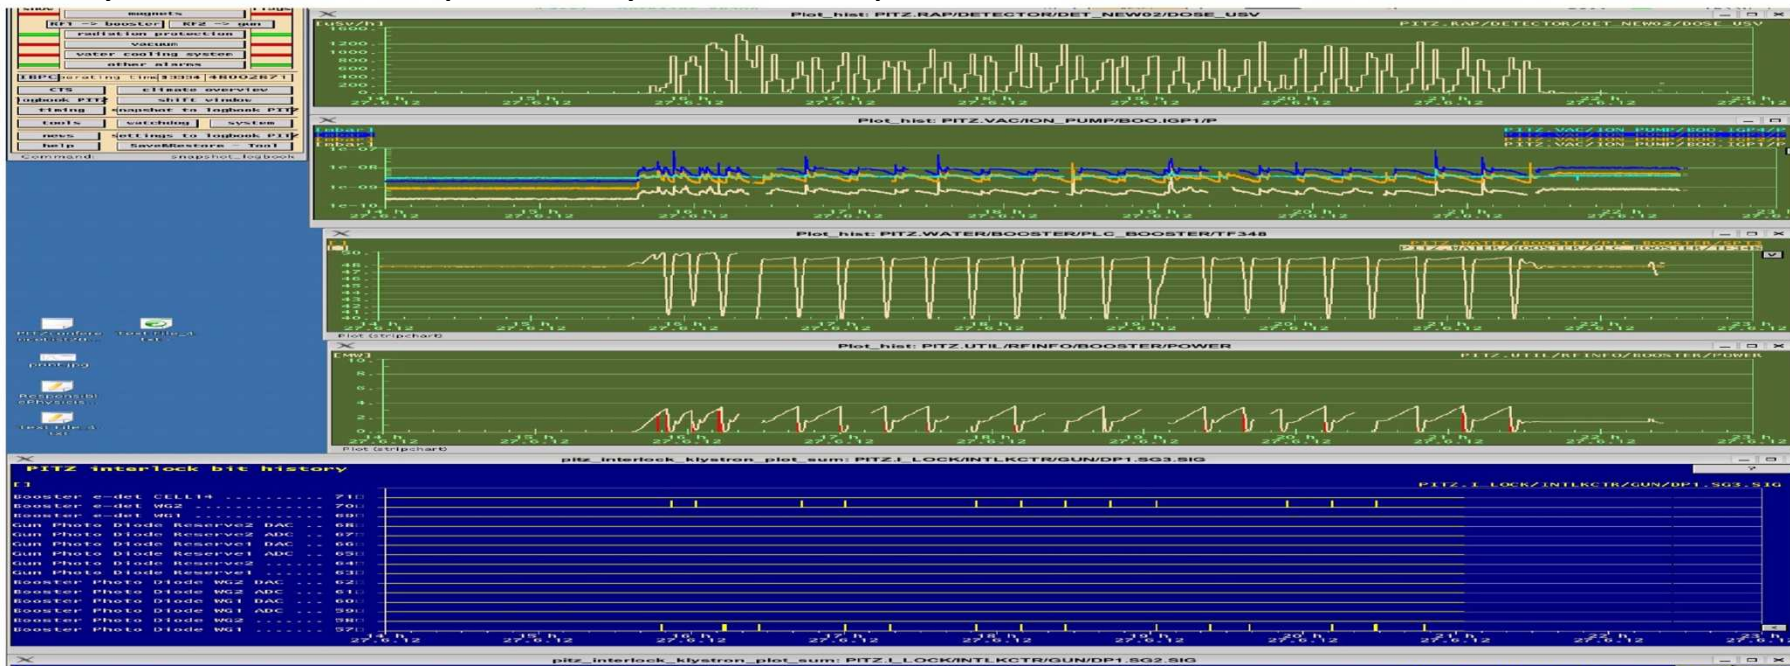
700 us pulse duration. High radiation around HEDA1. A lot of electron detector in WG2 ILs correlated with PD in WG1. Looks like we have a problem with WG2 RF window, may be we have to open the system for inspection

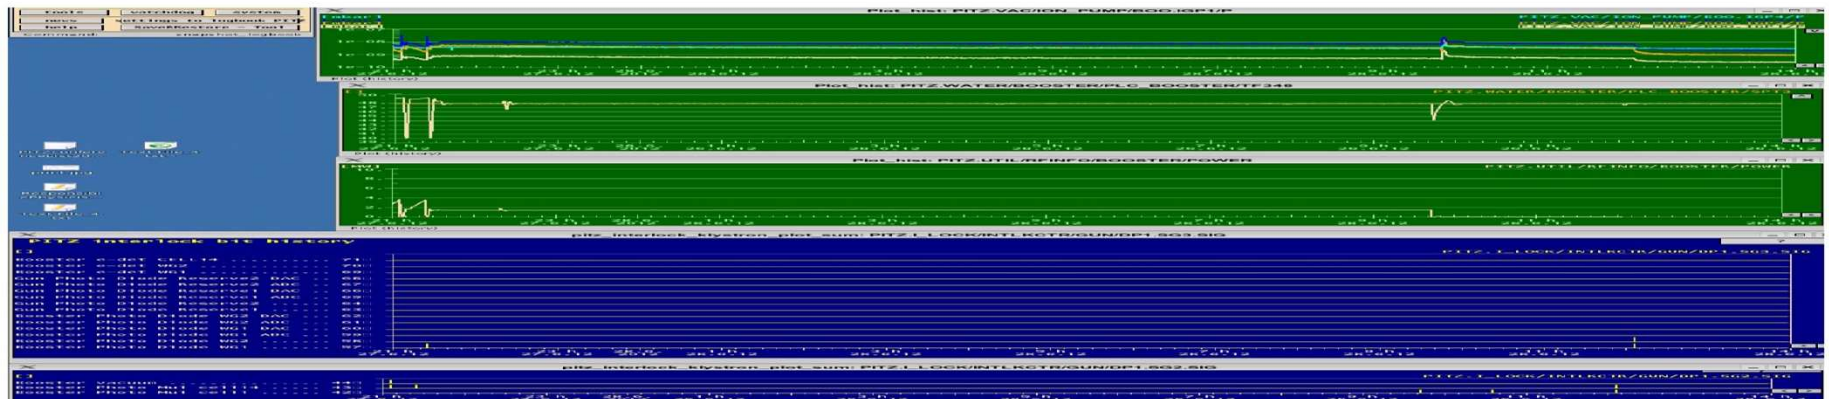
Conditioning at about 1.4 MW in the booster – good vacuum trend
