pitz_08_in

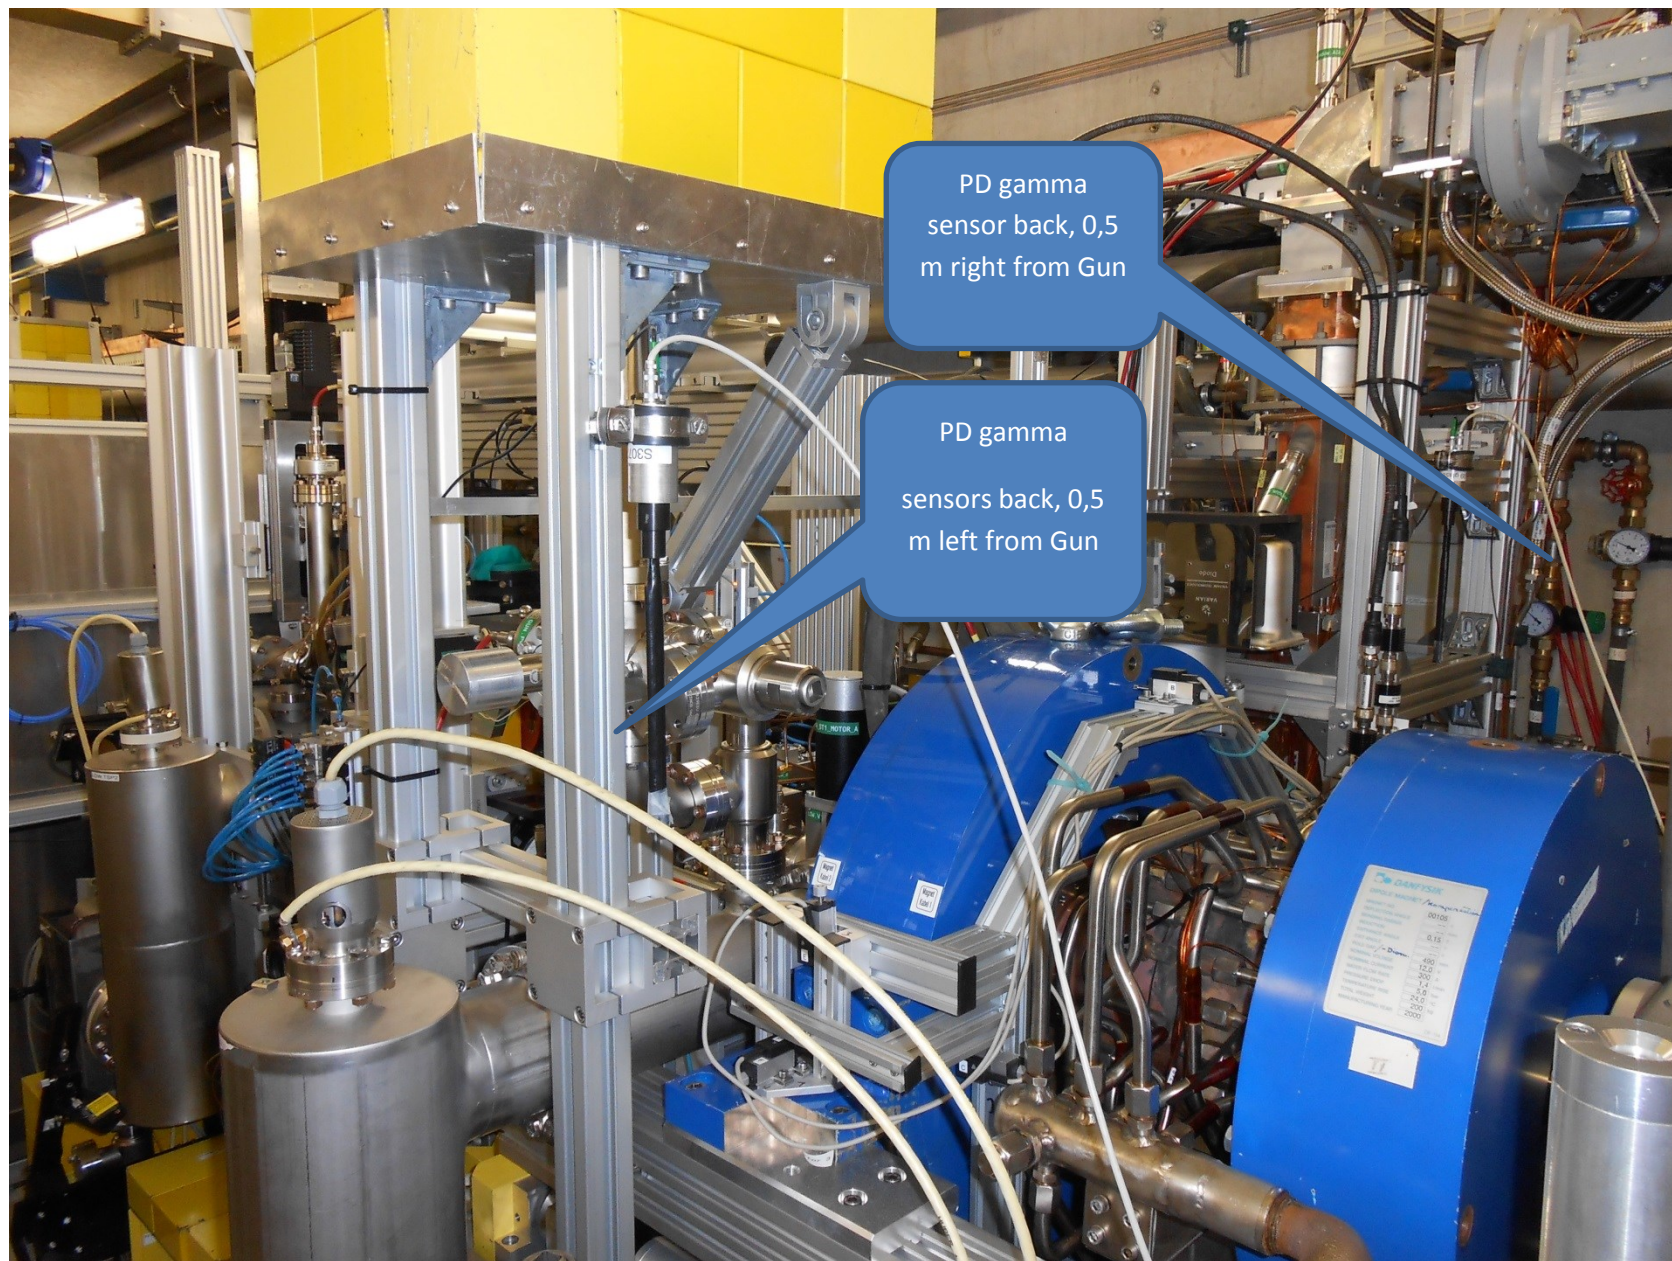
PD gamma
sensor back, 0,5
m right from Gun

PD gamma
sensors back, 0,5
m left from Gun
