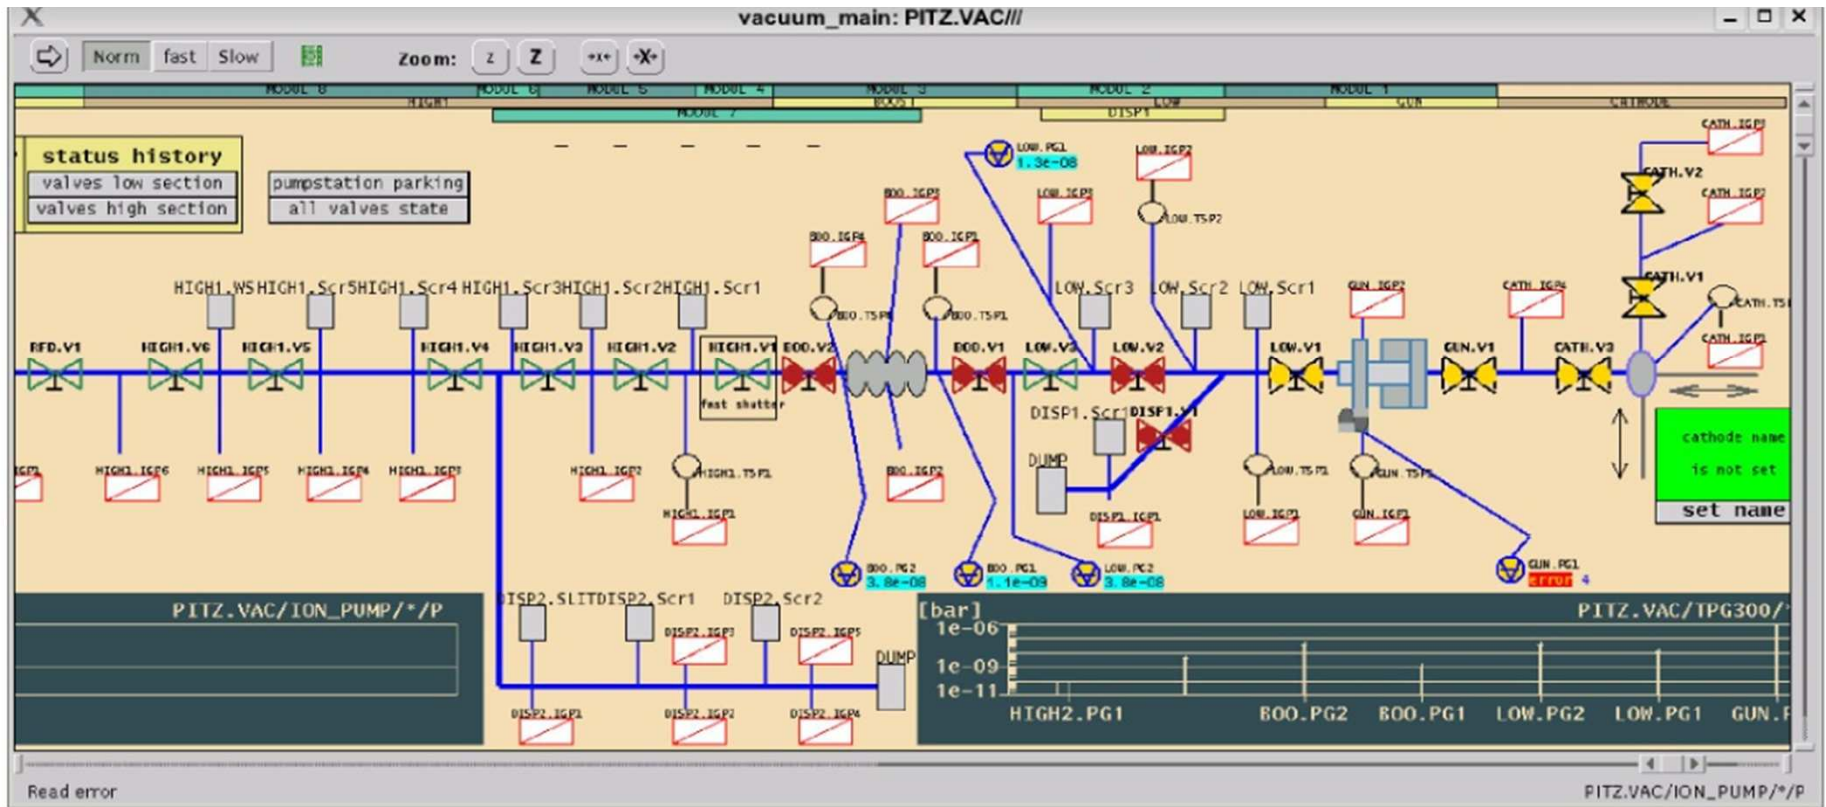
100 us pulse duration

Full power reached, but stable for very short time

At the same time no significant vacuum activity, only light

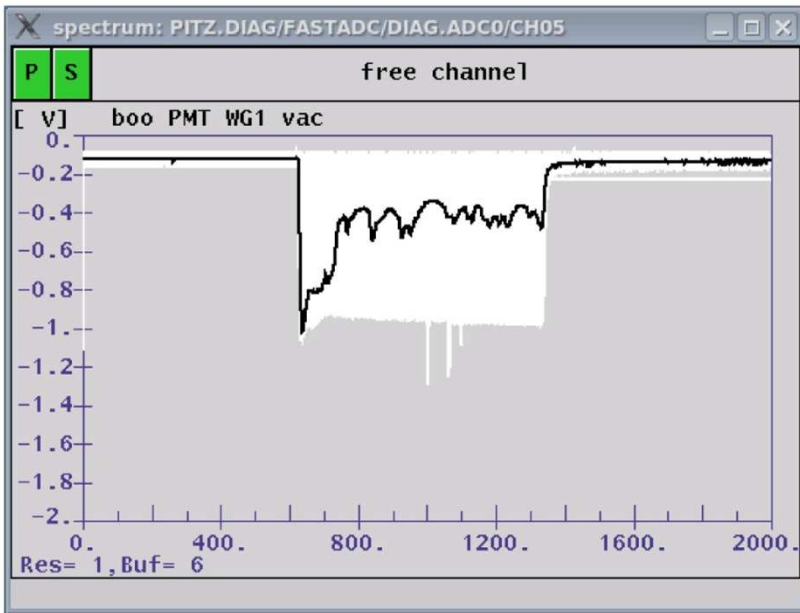
The horns at PMTs in WG1&2 a bit reduced after increasing of the filling time from 15 to 25 us

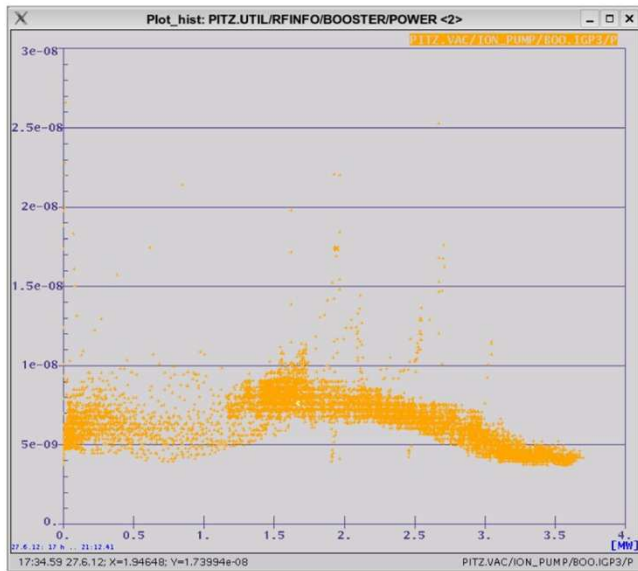
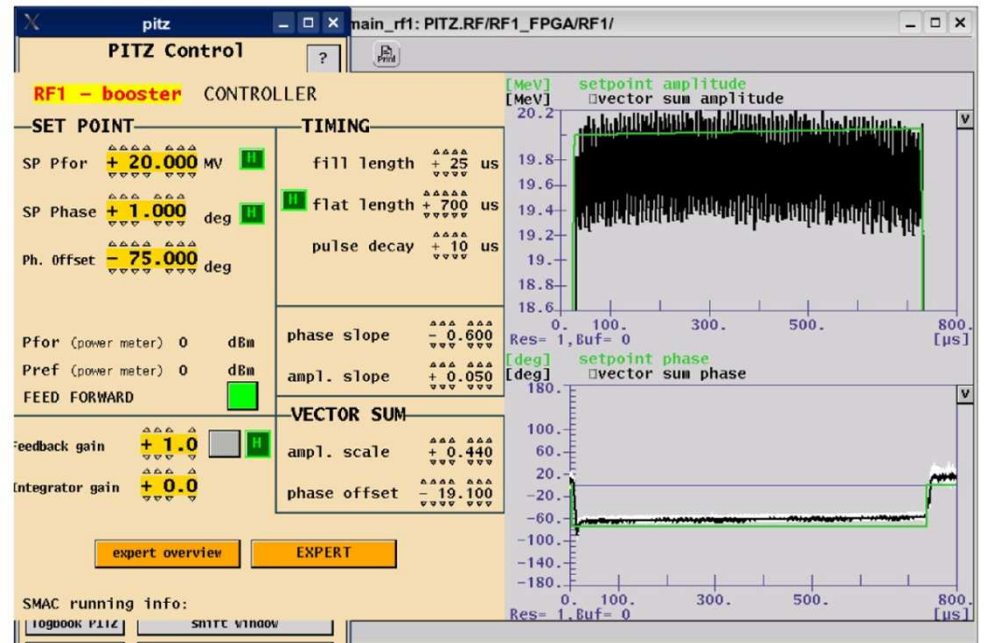
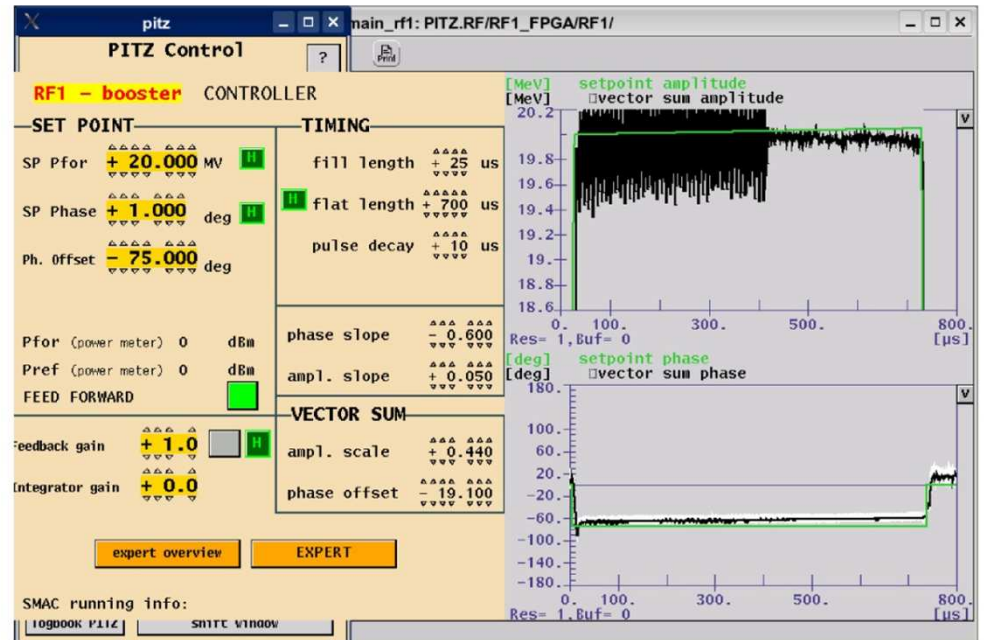
# Vacuum activity vs. power in the booster @ 700 us

700 us pulse duration. High radiation around HEDA1. A lot of electron detector in WG2 ILs correlated with PD in WG1. Looks like we have a problem with WG2 RF window, may be we have to open the system for inspection
