# PITZ Experience with Gun5.1

Gun5 measurements and Status of L-Band conditioning facility

Mikhail Krasilnikov for the PITZ team  
XFEL MAC, 08.11.2023

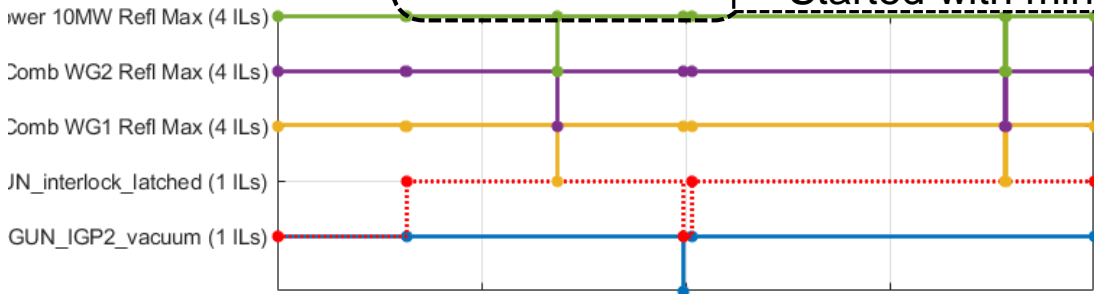
First hours run on 31.07.2023

Started with miniBDs, then...
